Agenda  
Village of Glen Ellyn  
Finance Commission Meeting  
Friday, July 14, 2023  
7:00 AM  
Glen Ellyn Civic Center, Room 301

## **Glen Ellyn Volunteer Fire Company**

Fire Station No.61 & No.62

### Fire Station No.61 Existing Condition Report

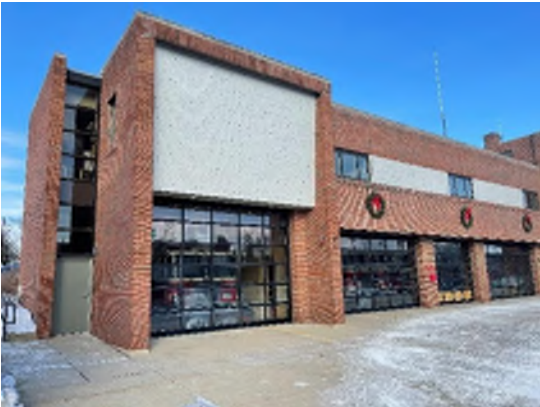
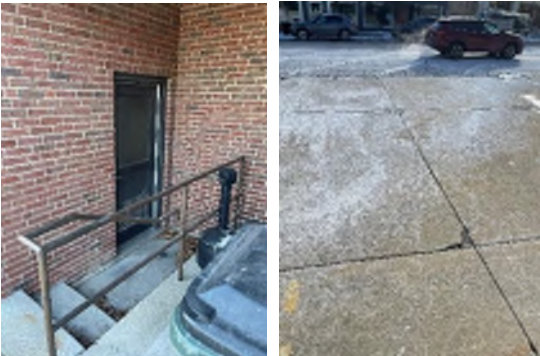
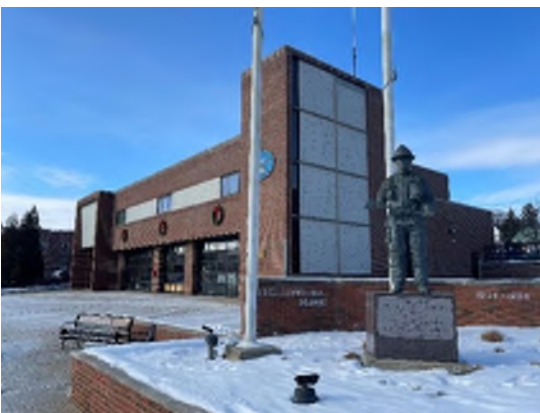
Fire Station No. 61 was originally built in 1956. The original station was two stories. There was an addition to the bays in the 1960's and an addition to the second story in 1997. The bays and original portion of the facility is constructed of CMU masonry bearing structure with face brick exterior on the front façade with accent tile panels. The second floor is precast concrete. The bays and original building's roofs are flat with steel bar joist structure. The interior walls at these locations are mainly CMU block partitions in the apparatus bay and bay support areas with gypsum board partitions in the admin and residence areas.

- The existing concrete apron at the front of the station is not large enough to pull the vehicles out for regular inspections as requires the staff to stop traffic downtown to back the vehicles into the apparatus bay. The depth of the apron should be increased to allow safer vehicle operation and required vehicle inspections.

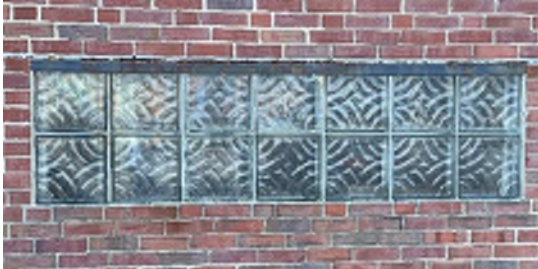
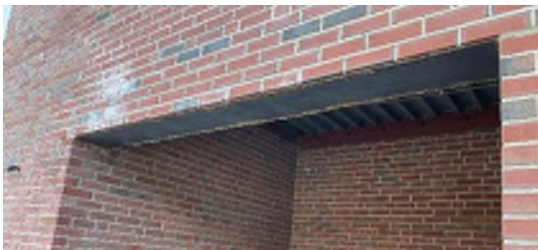
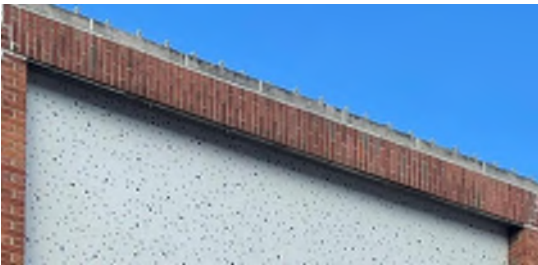
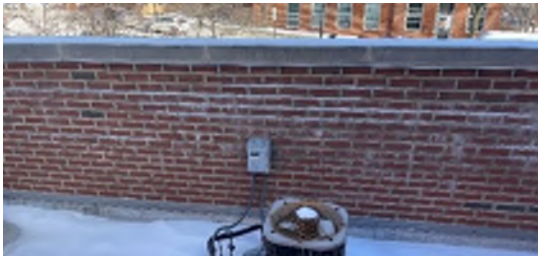
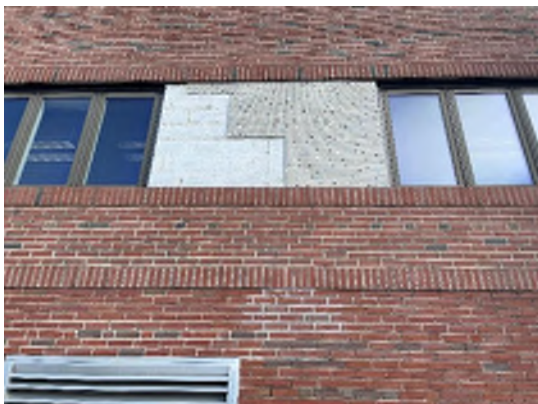
- The existing flat roof consists of roofing membrane, rigid insulation and is supported by steel decking and bar joists. The roofing membrane appears to be nearing the end of its life expectancy and should be replaced soon.

- There are several steel lintels at window and door openings that have surface rust present. If not addressed soon these lintels will continue to deteriorate and potentially allow water to penetrate the cavity wall and lead to other issues. It is suggested that all steel lintels be sanded and receive the required primer/paint coats to seal and protect the steel.

- The existing glass sectional overhead doors (1997) have missing glass panels, cracked seals and do not meet the current energy code. This condition results in a higher energy usage and cost for the Owner. Overhead doors appear to be at the end of their life expectancy and should be replaced soon.

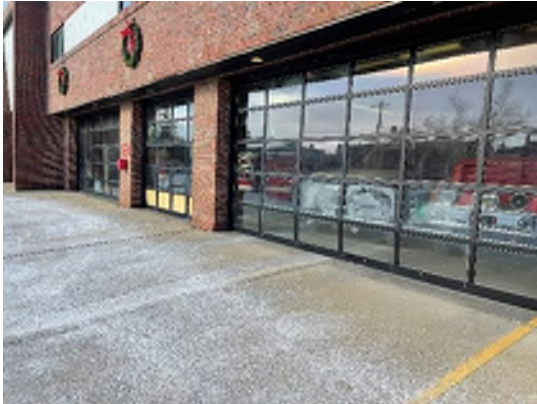
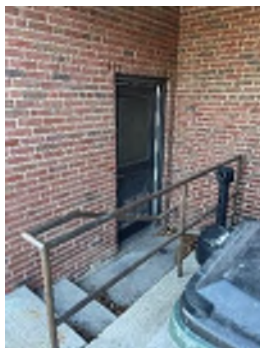
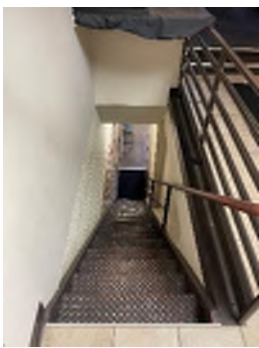
Since the building was constructed and last renovated, accessibility requirements have changed with the Americans with Disabilities Act (ADA). The accessibility guidelines mandate that all public facilities are to be designed, constructed, or altered to assure equal accessibility to all members of society. If any type of renovation within the building occurs, multiple accessibility violations would need to be addressed. The violations range from minor issues to larger problems that would require significant renovation work. Below is a summary of violations reviewed during the building assessment:

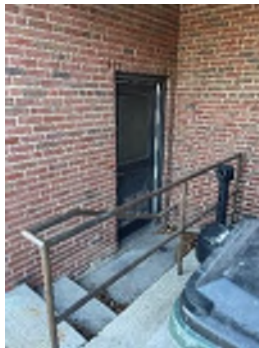
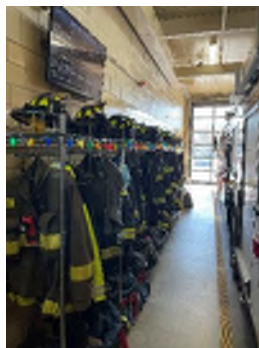
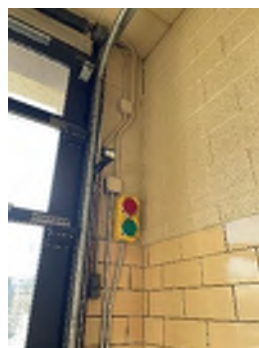
- Existing entrance doors do not meet the current Building and ADA codes and need to be addressed. See Building Code and Accessibility sections for additional information.
- There are (4) existing entrances into the station and none of them clearly designate a main or public entrance. All exterior HM doors do not have any sidelights or visions light glass provided. Existing hollow metal doors do not help designate entry into the facility or invite public. At a minimum, (1) door should be selected and designated as the main entry.
- There are no vestibules provided at entrances, this allows unconditioned air to enter conditioned spaces very time the door is opened. This condition results in a higher energy usage and cost for the Owner. At a minimum, designated main entry should be provided with a vestibule.

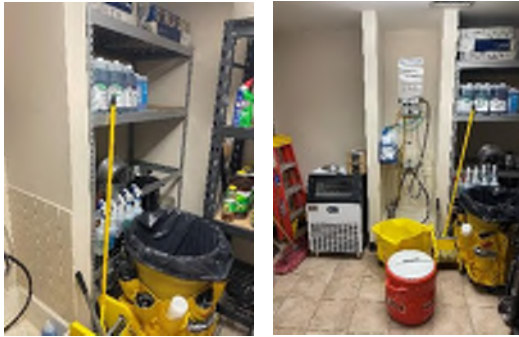
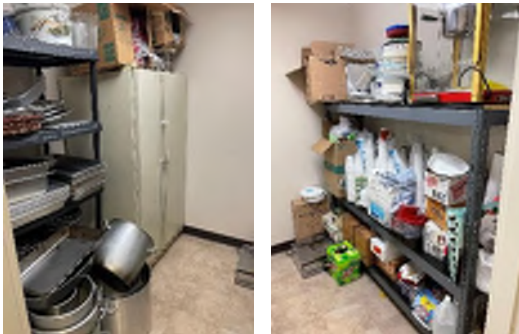
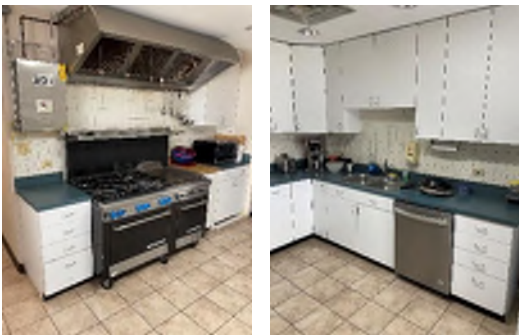
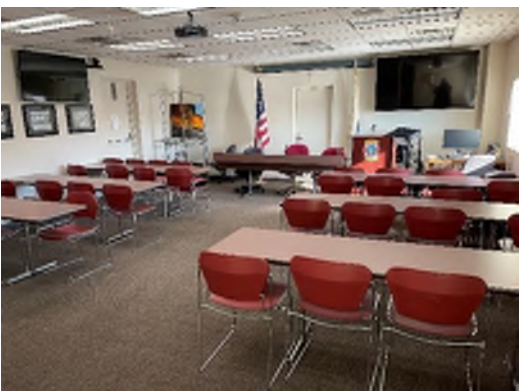
- Second floor mech room do not have code required floors drains provided. This issue needs to be addressed.
- Storage and supply rooms appear to be correctly sized. There is a potential opportunity to reorganize, and change replace shelving and remove unused equipment to provide more storage space.

- Existing training room is severely undersized. Currently training occurs weekly at this station. Existing training room was designed to seat (18) but (60+) attend weekly training sessions and require the sessions to be located at on the bay floor or at station 62. To correctly accommodate the current space needs for training this space needs to be larger.

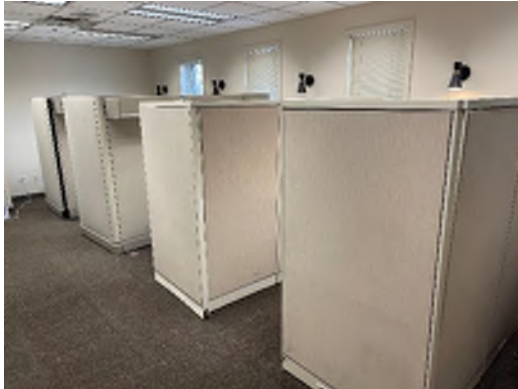
- There are (4) existing bunk areas separated by cubical partitions. Bunk count does not meet current need for future growth. Existing bunks do not allow required separation between individuals but does allow noise to easily reverberate throughout the entire room. Current trends have all 4 walls of the bunk room from floor to ceiling provide with sound batte insulation to reduce sound transfer, doors or door opening can be provided depending on the station's operation.
- (6) lockers are provided, this is not enough lockers to meet future growth. Additional lockers need to be provided. Current trends have the lockers either located in the individual bunk rooms or in a combined locker room with toilet/shower rooms directly located off the locker room to allow for indivual changing space.

- Countertops do not meet ADA requirements in regard to maximum work surface height requirements. This needs to be addressed.

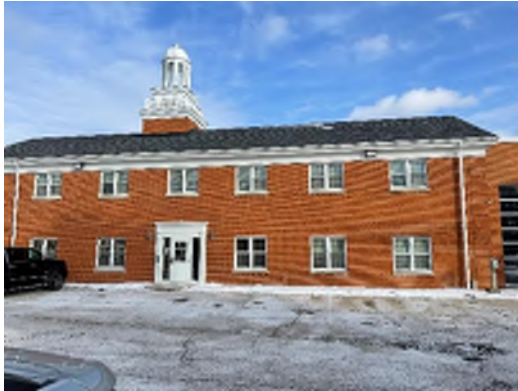
Fire Station No. 62 was originally built in 1972. The original station is two stories. There was a significant renovation to the existing station in 1997 and not much has been done to the station since then. The facility is constructed of CMU masonry bearing structure with face brick exterior. The second floor is composite concrete deck with steel bar joists. The bay roofs are flat, structure is steel bar joists, the house is wood trusses with plywood deck and shingles. The interior walls at these locations are mainly CMU block partitions in the apparatus bay and bay support areas with gypsum board partitions in the residence areas.

- Several areas of veneer brick were noted as having efflorescence or cracked grout joints at walls. Though some areas appear to have been tuck pointed or caulked but there were many other areas that have been yet to be addressed. These issues appear to be the result from water penetrating the cavity wall from multiple sources such as parapets, and heads and sills of windows. These issues should be addressed by tuckpointing all of the exterior brick veneer walls.
- Existing flat roof membrane and pitched roof shingles appear to be in good shape. Roofs should be regularly inspected and maintained per manufacturer's warranty.
-

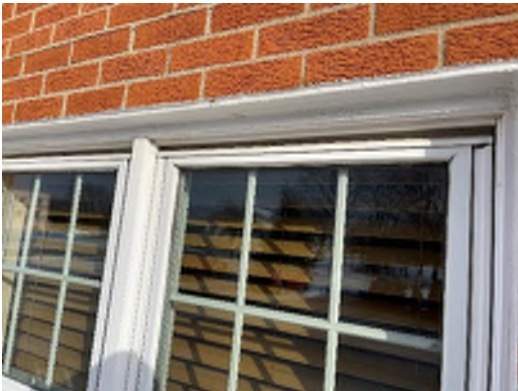
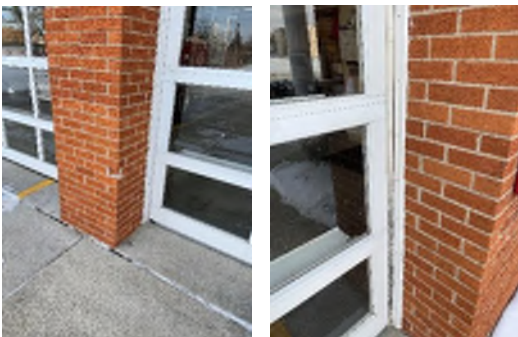
- Due to the time frame in which the building was constructed and from reviewing the original construction drawings, the exterior cavity walls contain approximately 1" of rigid insulation. This is a third of the required amount based on today's construction standards and Energy Code requirements. This condition results in a higher energy usage and cost for the Owner.

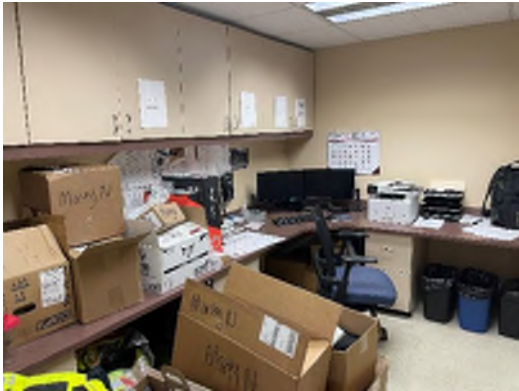
- What once was a report writing room is now EMS storage/office. Office function is underused due to the amount of work space being used for overflow storage. Additional storage space should be provided to allow for the work room to be properly utilized for report writing and studying.
- Existing casework and plastic laminate casework appears to be in good condition.

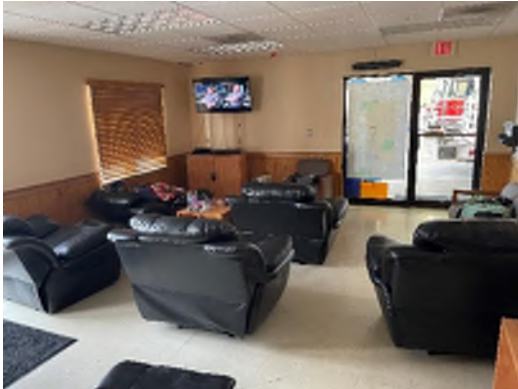
- Existing dayroom is located on the North side of the station. The front door of the station opens directly into the dayroom. Front door faces the main road, this creates for an undesirable entrance to the public. Public and semi-private spaces should be addressed at this station.
- Existing dayroom is undersized, staff had commented on the existing floor plan not allowing the dayroom and kitchen/dining to be directly adjacent to one another. A great room concept allows the staff to more frequently interact with each other during meal prep, dining and group activities.
- There is not an existing gas curb between the apparatus bay and dining room, this is not required but at a minimum the existing storefront door should have weather seals to minimized exhaust and contaminants from entering the living spaces directly.

- Existing mechanical room is currently being used for overflow supply storage. To maximize storage in this space it is suggested to utilize storage shelving units to get loose boxes off the floor incase of water heater leaks.

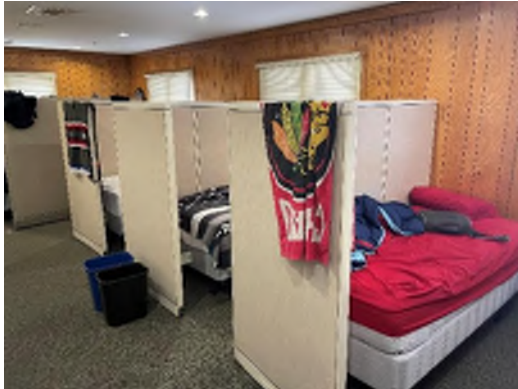
- There are (4) existing bunk areas separated by cubical partitions. Bunk count does not meet current need or future growth. Existing bunks do not allow required separation between individuals but does allow noise to easily reverberate throughout the entire room. Current trends have all 4 walls of the bunk room from floor to ceiling provide with sound batte insulation to knock down sound transfer, doors or door opening can be provided depending on the station's operation.
- (6) lockers are provided, this is not enough to meet future growth. Additional lockers need to be provided. Current trends have the lockers either located in the individual bunk rooms or in a combined locker room with toilet/shower rooms directly located off the locker room to allow for individual changing space.

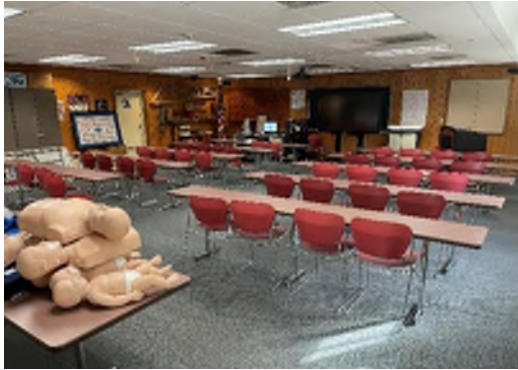
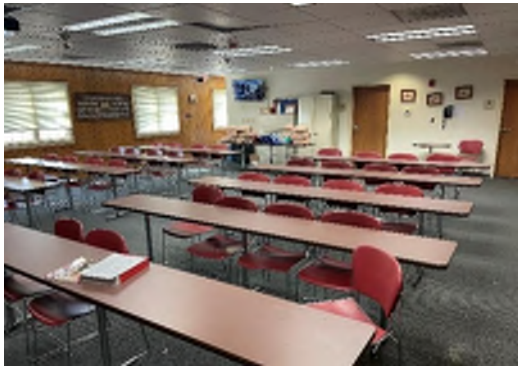
- Existing training room is severely undersized. Currently training occurs weekly at this station. Existing training room was designed to seat (18) but (60+) attend weekly training sessions and require the sessions to be located at on the bay floor or at station 62. To correctly accommodate the current space needs for training this space needs to be larger.

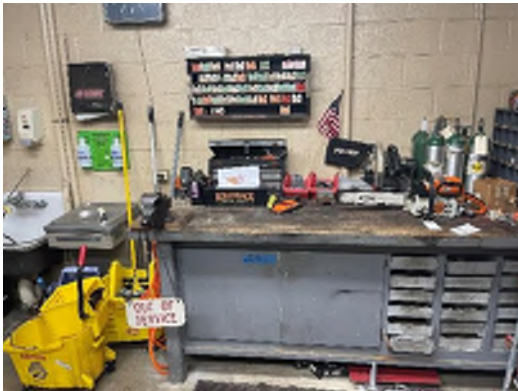
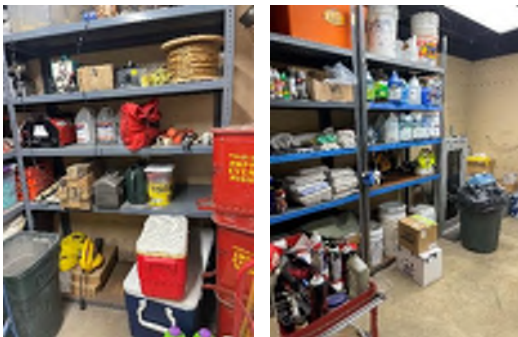
- The lack of bay support and training storage is currently a large issue at this station. Approximately 500 square feet of apparatus floor is being occupied by miscellaneous training equipment, props and materials. These items are required for the Companies required training and need to be housed close to where training occurs due to operations. Due to the lack of additional storage areas at the existing station the Company is forced to take up valuable bay space for storage. By storing these teams on the bay these items take up space for additional vehicle storage by the Company, County and MABAS at the station. The lack of bay support and training storage needs to be addressed.
