Agenda  
Village of Glen Ellyn  
Special Village Board Workshop  
Monday, August 26, 2024  
6:00 PM  
Glen Ellyn Civic Center, Room 301

## **Discussion of the Acceptance of the Public Improvements for the Main Street Garage**

At the request of the Village of Glen Ellyn, Walker Consultants performed a Visual Review of the 400 Apex Parking Facility in Glen Ellyn, Illinois. The objectives of this Condition Assessment were to perform a visual review of the parking facility's readily observable structural and waterproofing systems to identify current distress and/or deterioration.

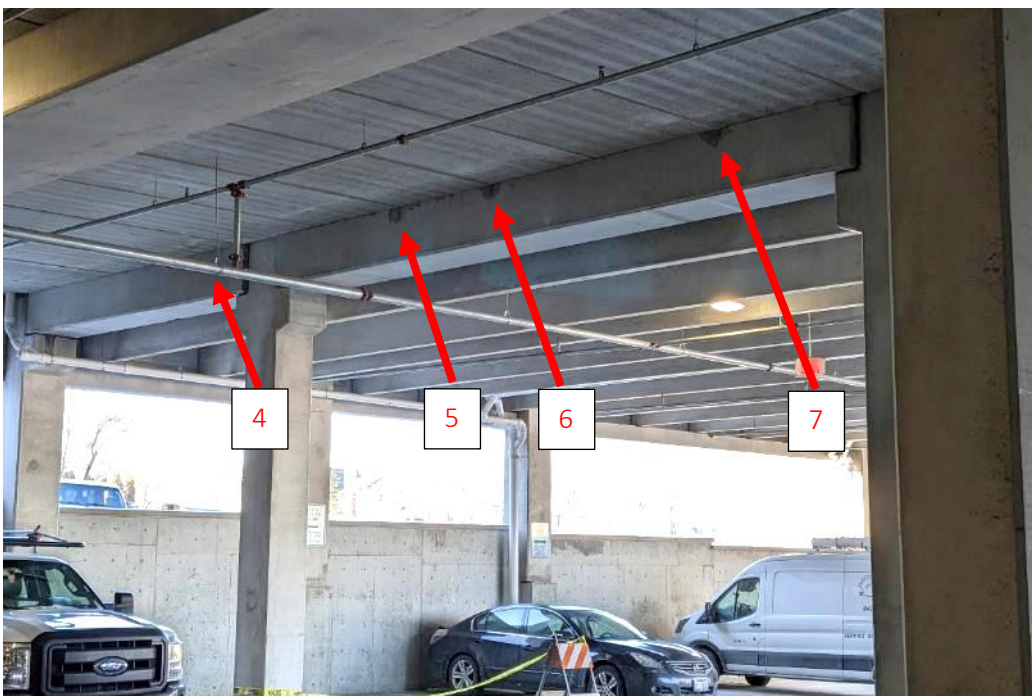
- d. Spall 4 along Grid Line 7.8, between Grids D and E. Concrete was reported to have fallen to the ground at this location in January 2023. The spall appeared shallow and was semicircular in shape. The presence of a bearing pad was not obvious from the ground.

Photo 9. Spall 4 along Grid 7.8 from Photo 8. Note, presence of a bearing pad is not obvious from ground.

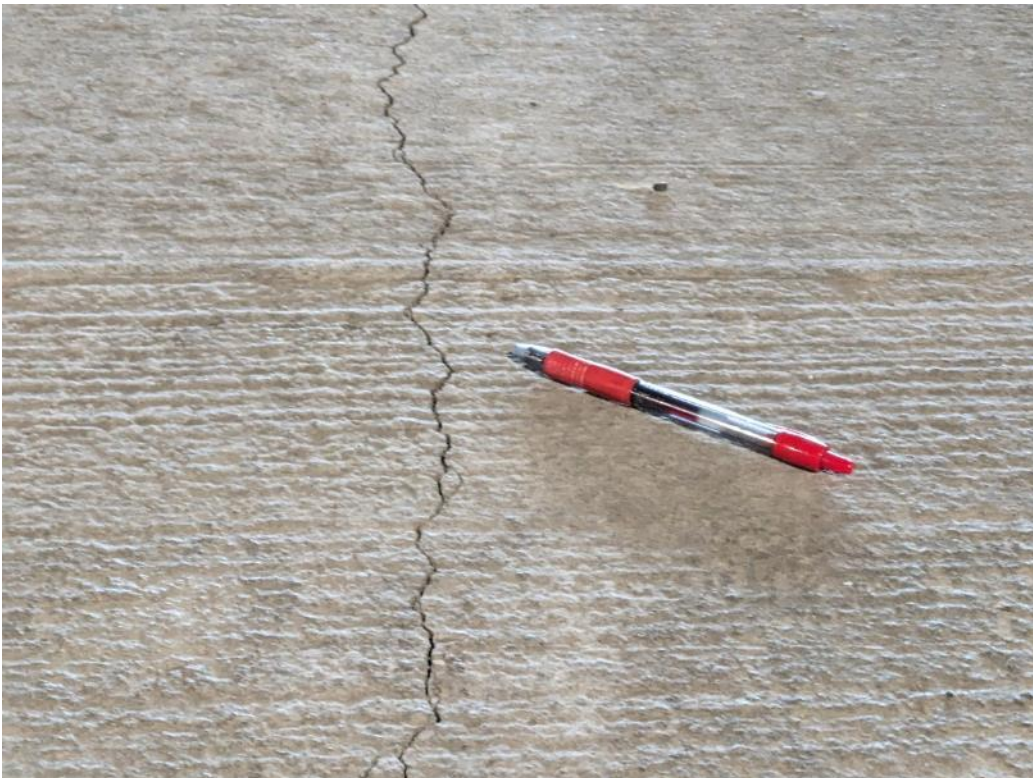
present. Due to the lack of isolation control joints, narrow cracking frequently radiated from the column corners (Photo 23).

Photo 23. Typical diagonal slab-on-ground cracks off Finger columns.

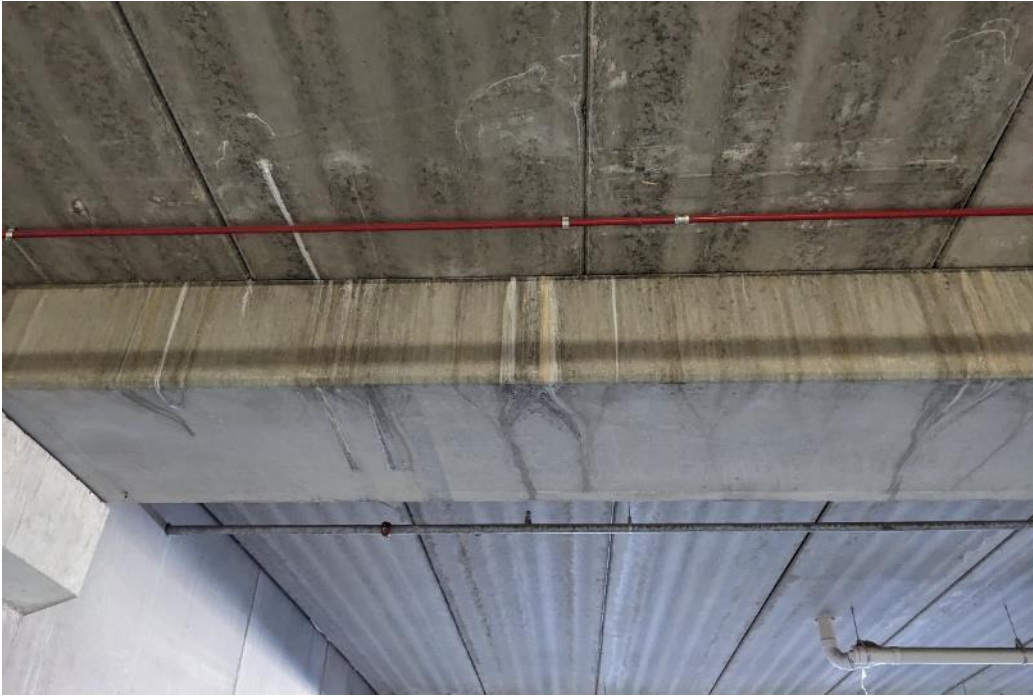
2. In addition to the water leakage stains, corrosion stains were present at a few beam locations (Photo 28) and at the south perimeter wall (Photo 29).

Photo 28. Water leaching and corrosion stains along the length of a beam observed from the 1<sup>st</sup> level.

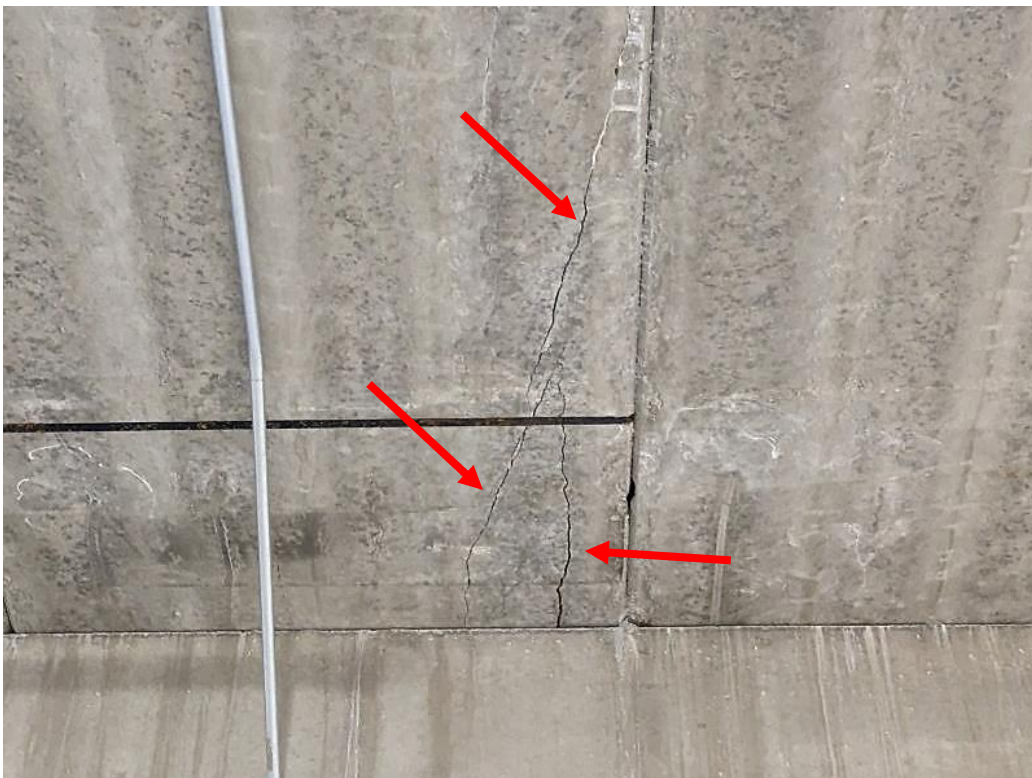
Photo 37. Overall view of a hollow core plank that has cracked.

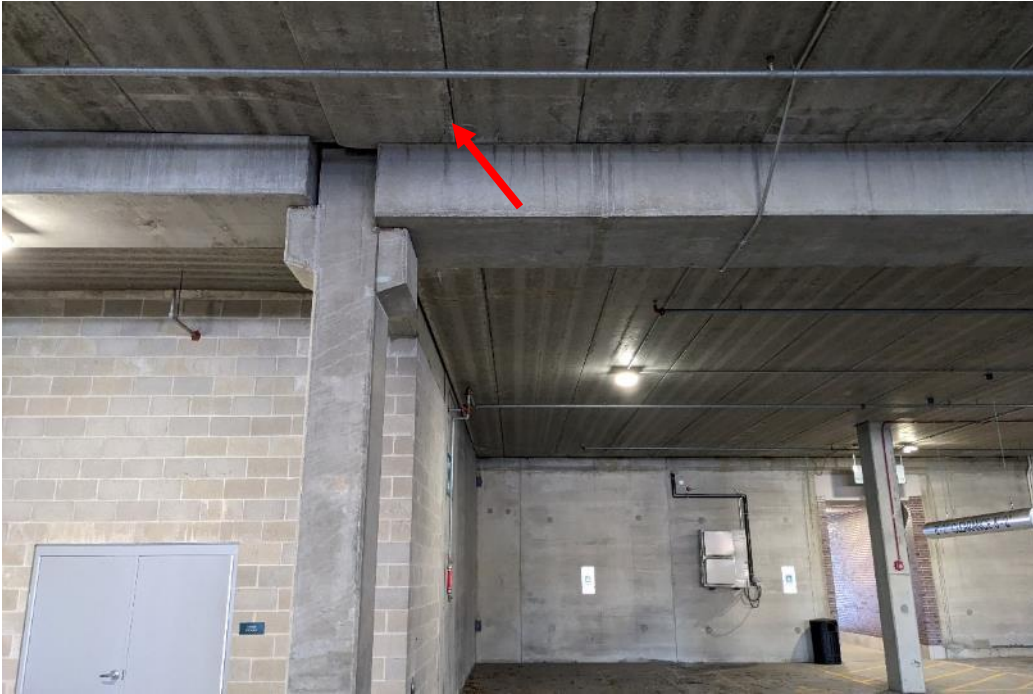
Photo 38. Close-up of the crack indicated in the previous photo.

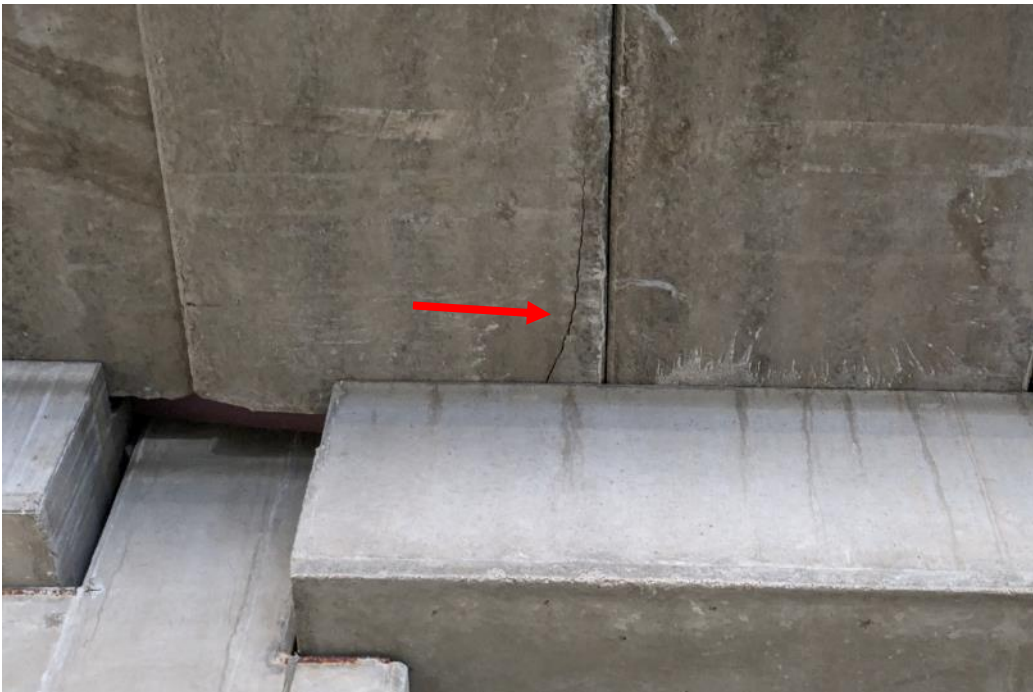
Photo 39. A hollow core plank with a crack near the supported end.

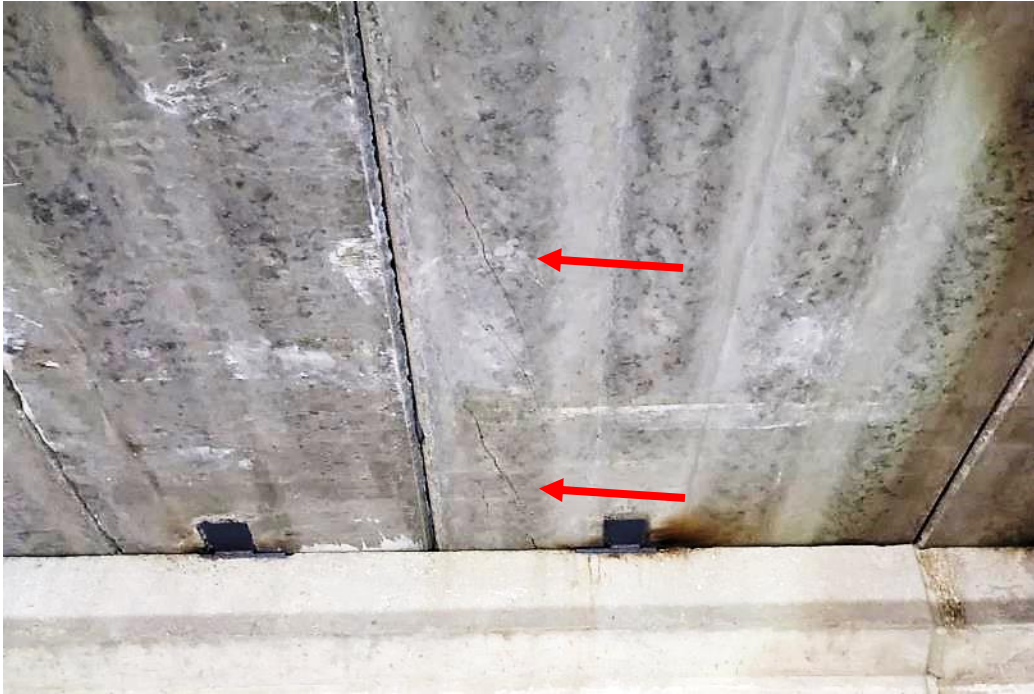
Photo 40. Another crack on a hollow core plank with efflorescence.

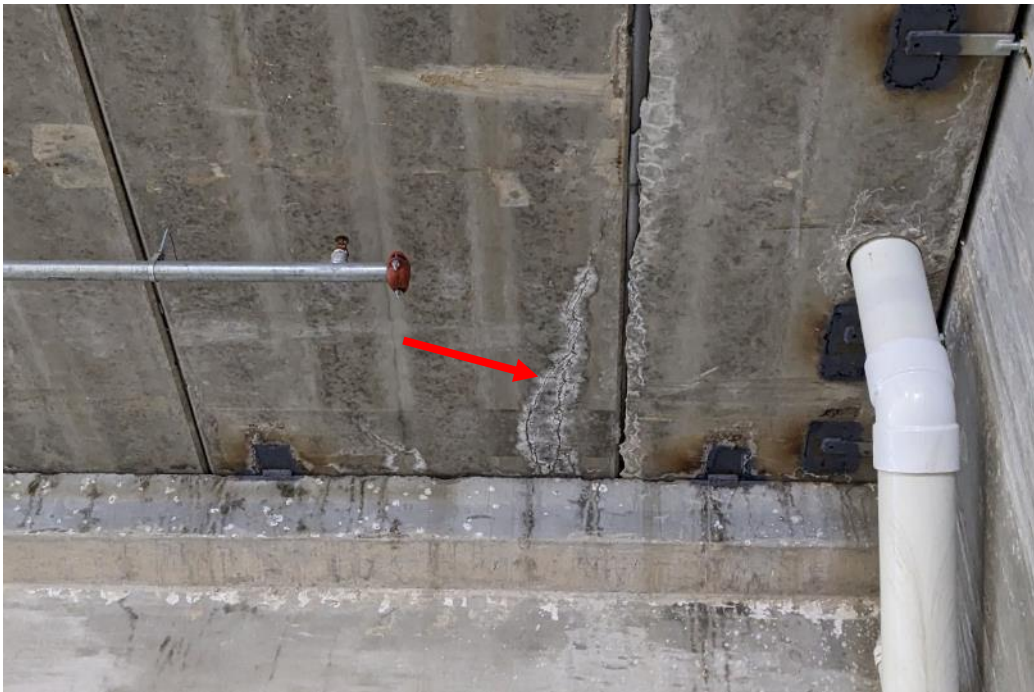
7. A concrete distress spall was present at the end of one of the inverted tee beams along Grid 4 (Photo 41).
8. A small concrete delamination/spall was present in a wall haunch supporting the hollow core planks along Grid 1 (Photo 42).

Photo 41. Concrete spall at the end of the inverted tee beam along Grid 4.

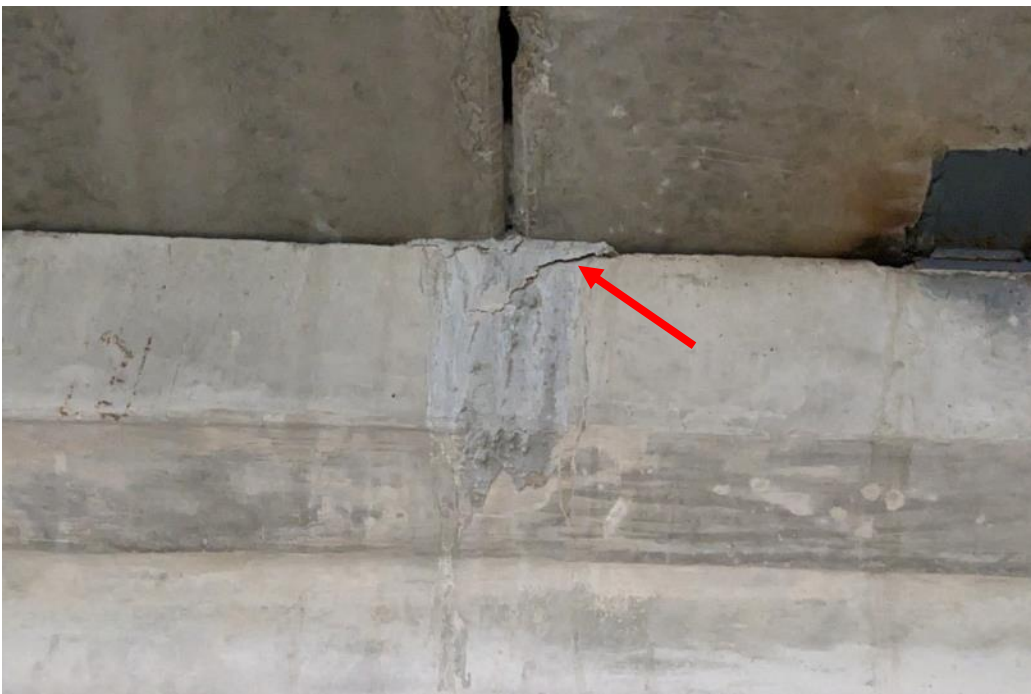
9. A large concrete delamination with corrosion staining was observed in the L-beam supporting the double-tees in the finger near the west entrance (Photo 43).

Photo 43. A delaminated concrete L-beam with corrosion staining near the west entrance in the finger.

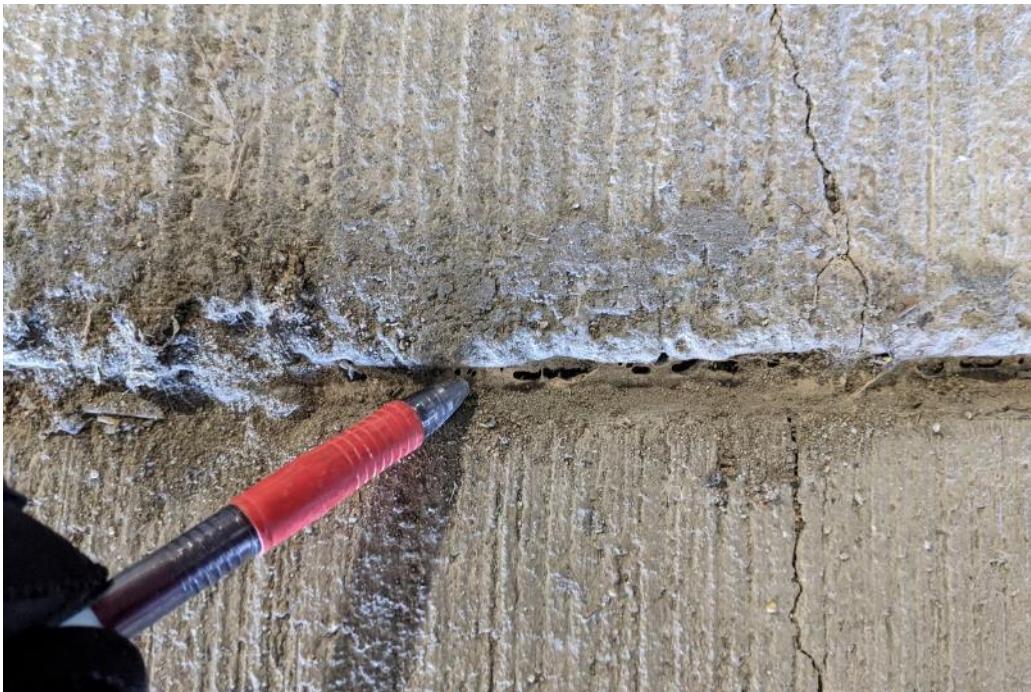
Photo 61. Additional failed construction joint sealant.

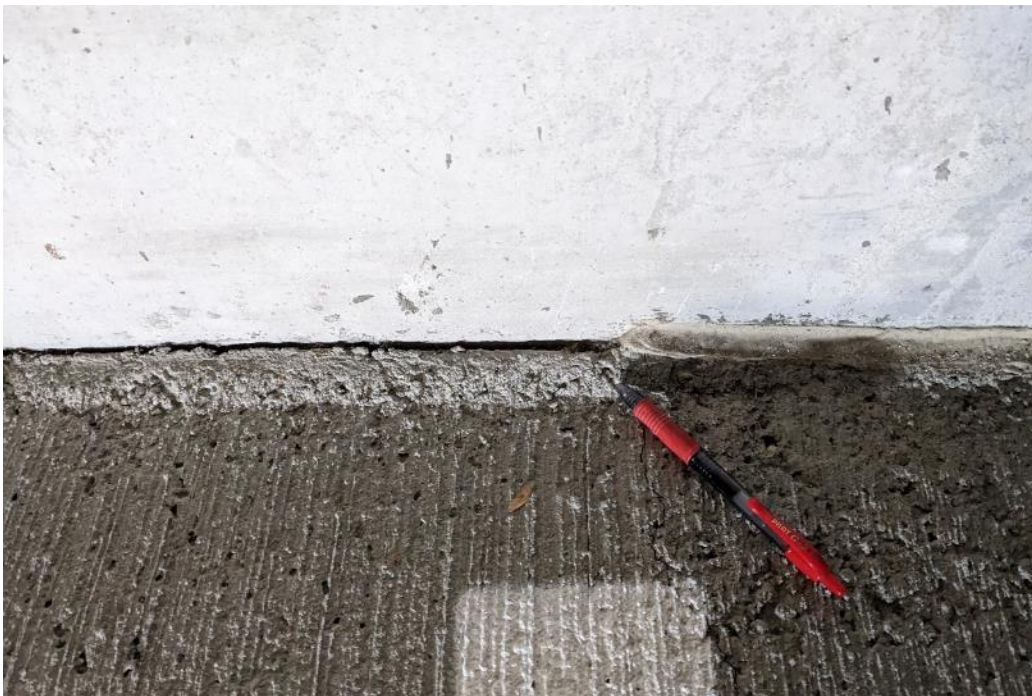
Photo 63. Shear walls typically missing cove sealant along the base. Also note failed control joint sealant.
