Agenda  
Village of Glen Ellyn  
Special Village Board Workshop  
Monday, September 9, 2024  
6:00 PM  
Glen Ellyn Civic Center, Room 301

## **Discussion of the Acceptance of the Public Improvements for the Main Street Garage**

At the request of the Village of Glen Ellyn, Walker Consultants performed a Visual Review of the 400 Apex Parking Facility in Glen Ellyn, Illinois. The objectives of this Condition Assessment were to perform a visual review of the parking facility's readily observable structural and waterproofing systems to identify current distress and/or deterioration.

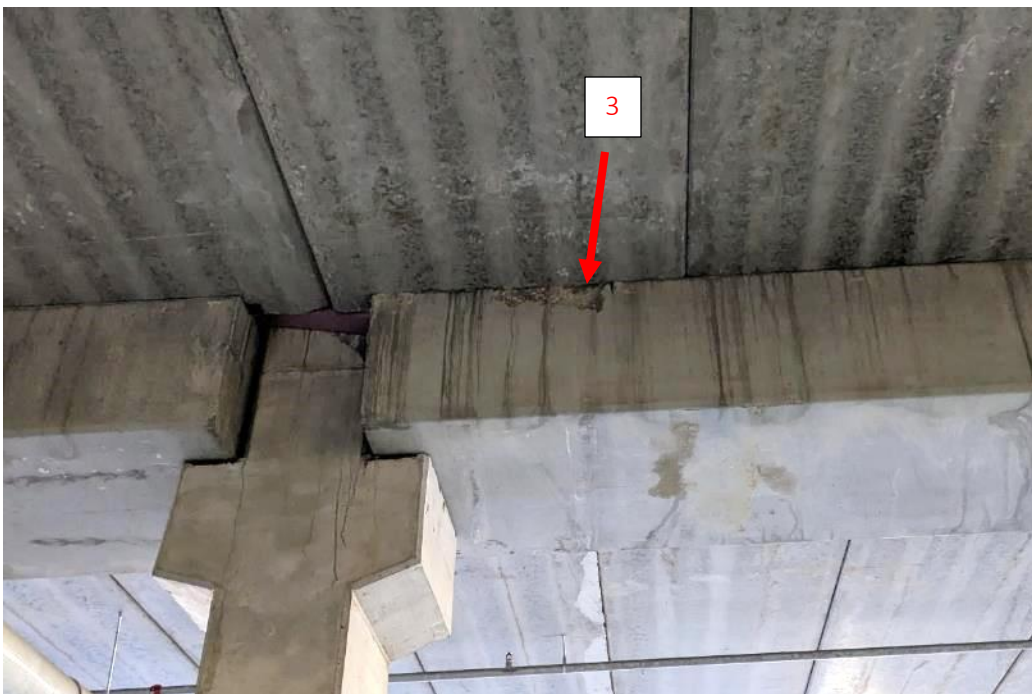
- c. Spall 3 along Grid Line 5, between Grids E and F. After concrete had fallen at Spall 1, cracking was observed in the face of the beam at this location. The beam was hammer sounded and deteriorated concrete removed to expose the spalled cavity. The spall appeared shallow and was rectangular in shape extending parallel to the length of the bearing. The presence of a bearing pad was not obvious from the ground.

Photo 7. Close-up of previous photo of beam spall at Gridline 5. Note, presence of a bearing pad is not obvious from ground.

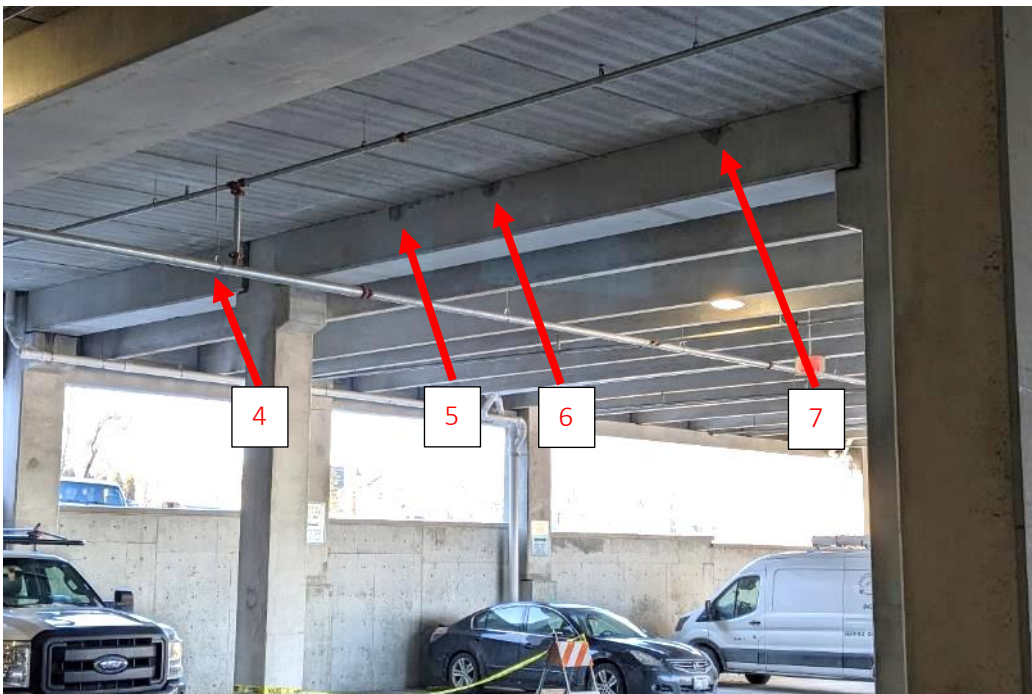
- d. Spall 4 along Grid Line 7.8, between Grids D and E. Concrete was reported to have fallen to the ground at this location in January 2023. The spall appeared shallow and was semicircular in shape. The presence of a bearing pad was not obvious from the ground.

Photo 9. Spall 4 along Grid 7.8 from Photo 8. Note, presence of a bearing pad is not obvious from ground.

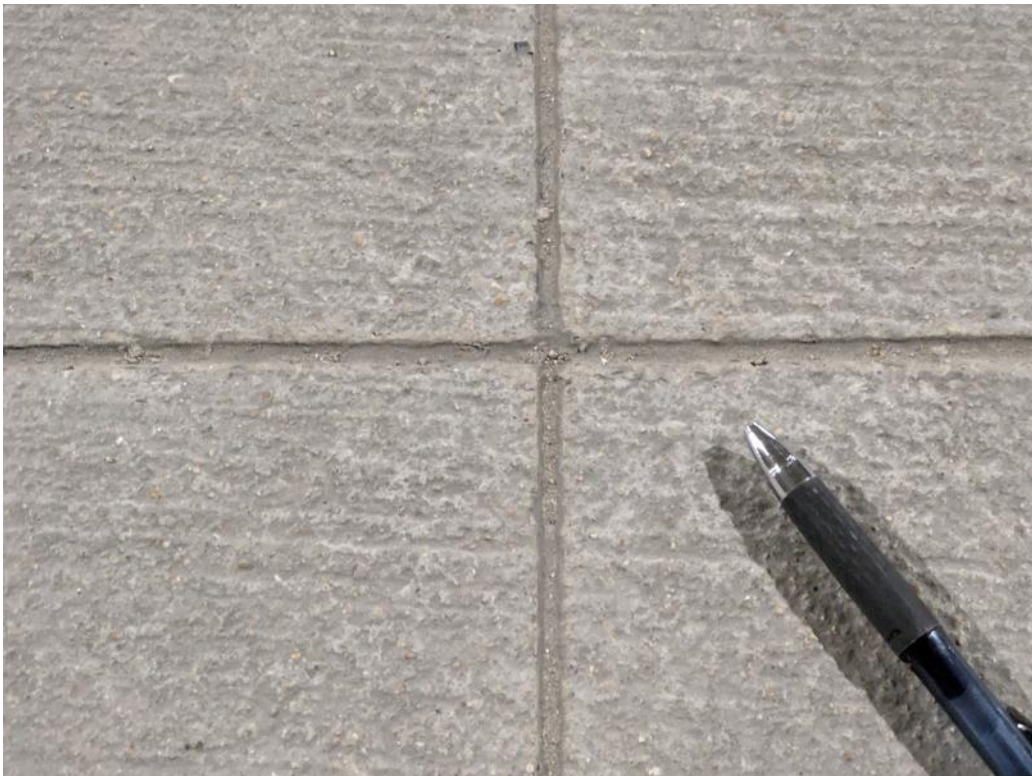
Photo 17. Typical slab-on-ground with missing control joint sealant.

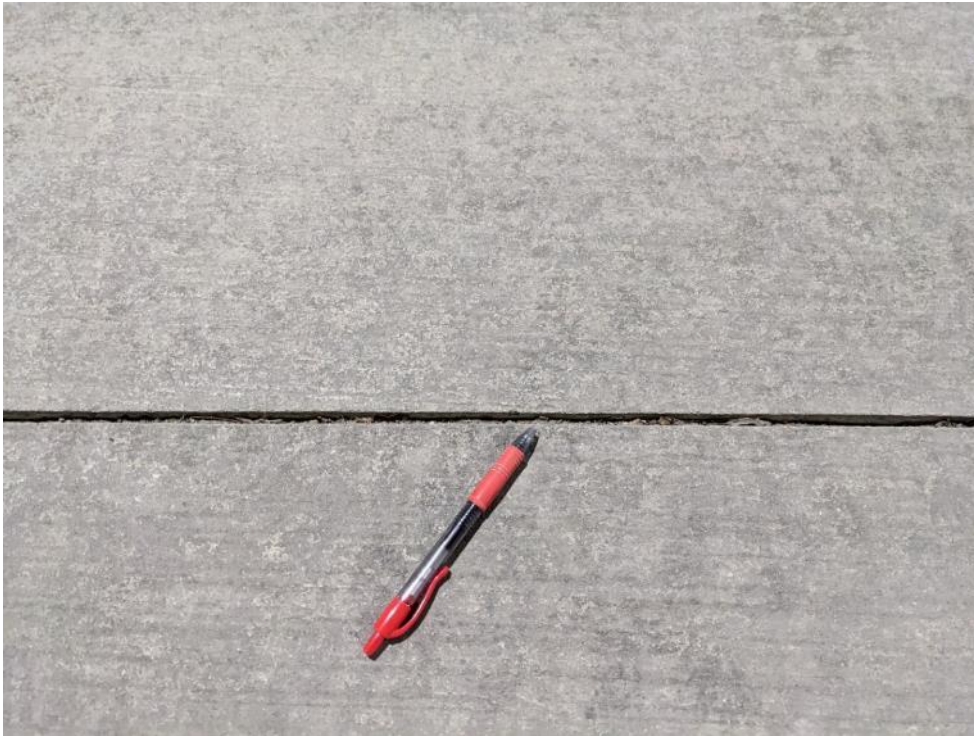
Photo 19. Missing slab-on-ground control joint sealant with small spalls along the joint in the finger.

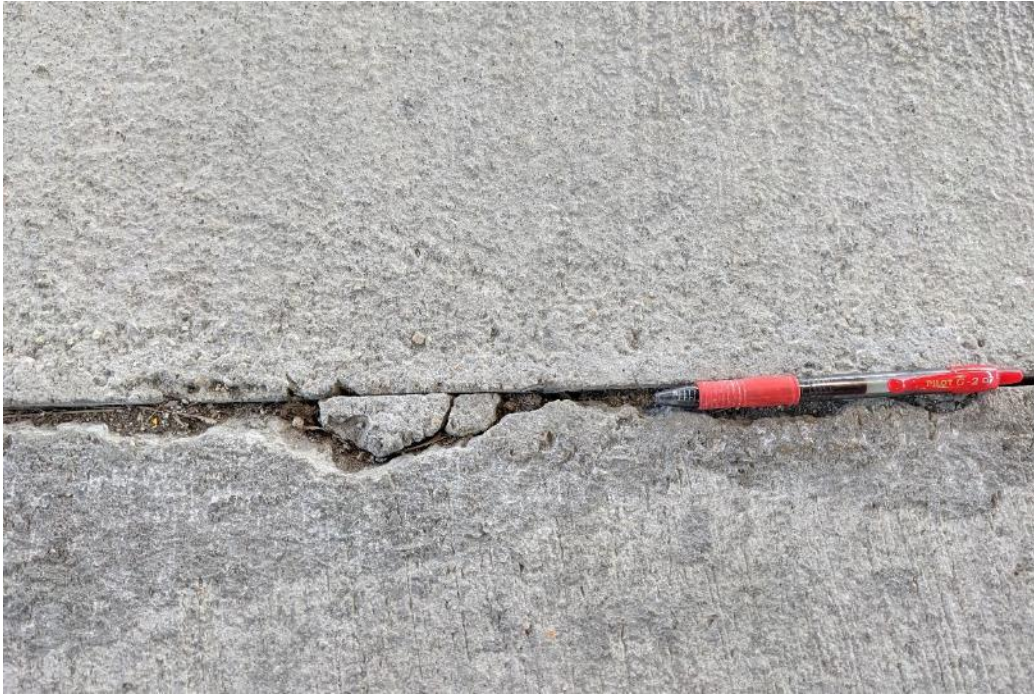
Photo 20. Missing slab-on-ground control joint sealant with small spalls along the joint in the finger.

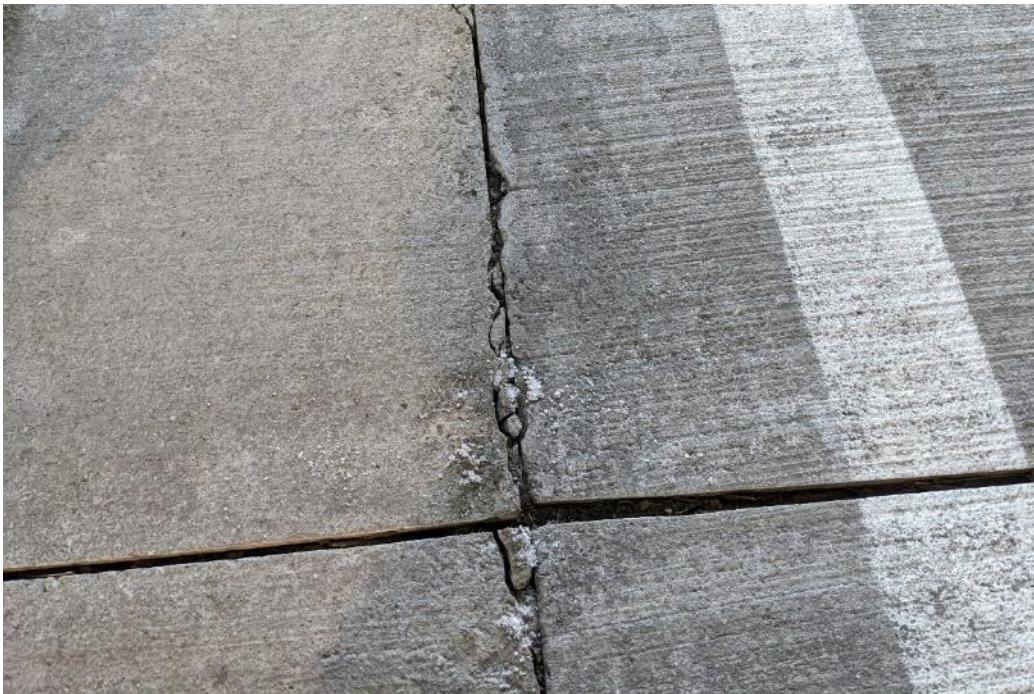
Photo 21. Typical narrow crack in the slab-on-ground.

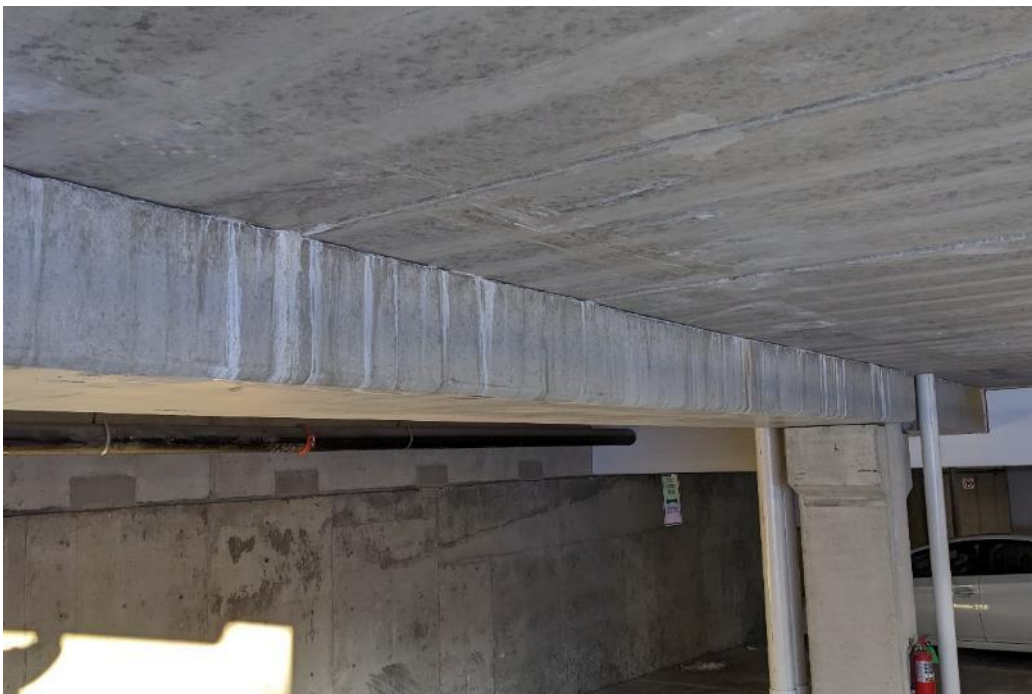
Photo 27. Water leaching stains typical along the length of a beam observed from the 1<sup>st</sup> level.

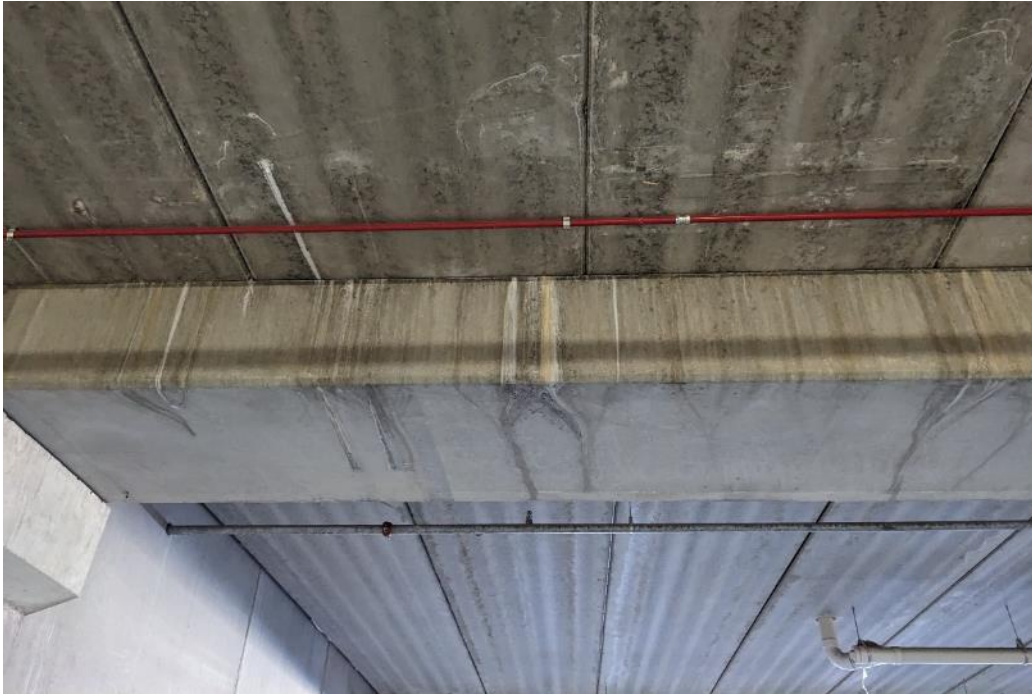
Photo 28. Water leaching and corrosion stains along the length of a beam observed from the 1<sup>st</sup> level.

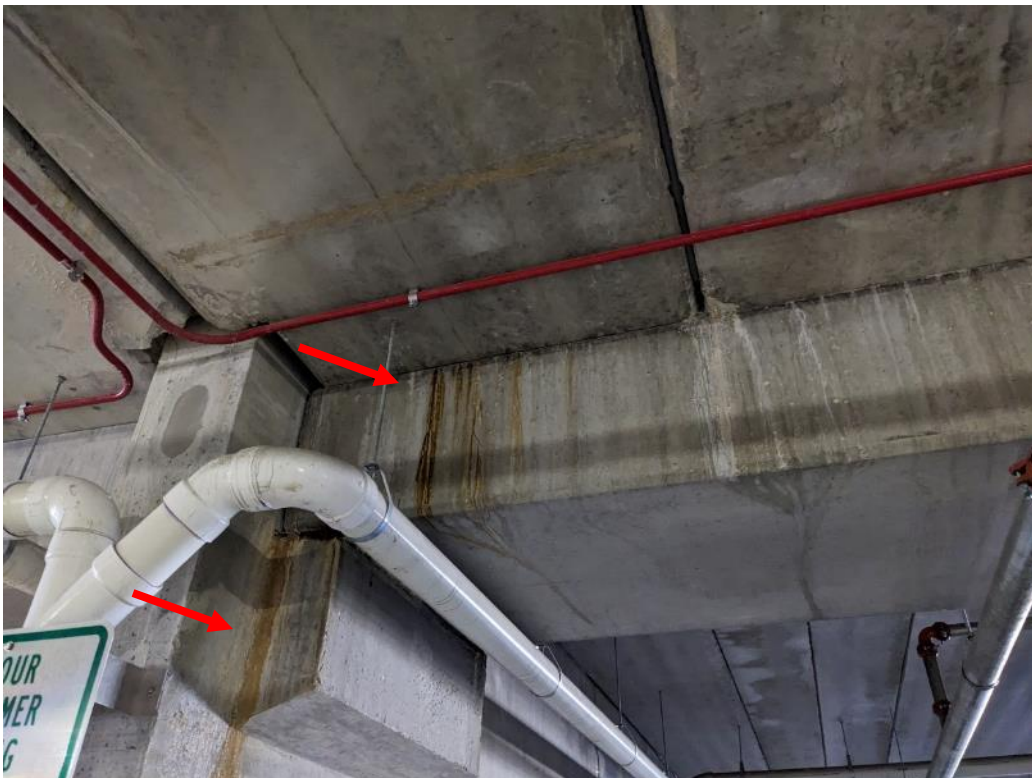
Photo 29. Corrosion and water staining at a wall near the 1<sup>st</sup> level south entrance.

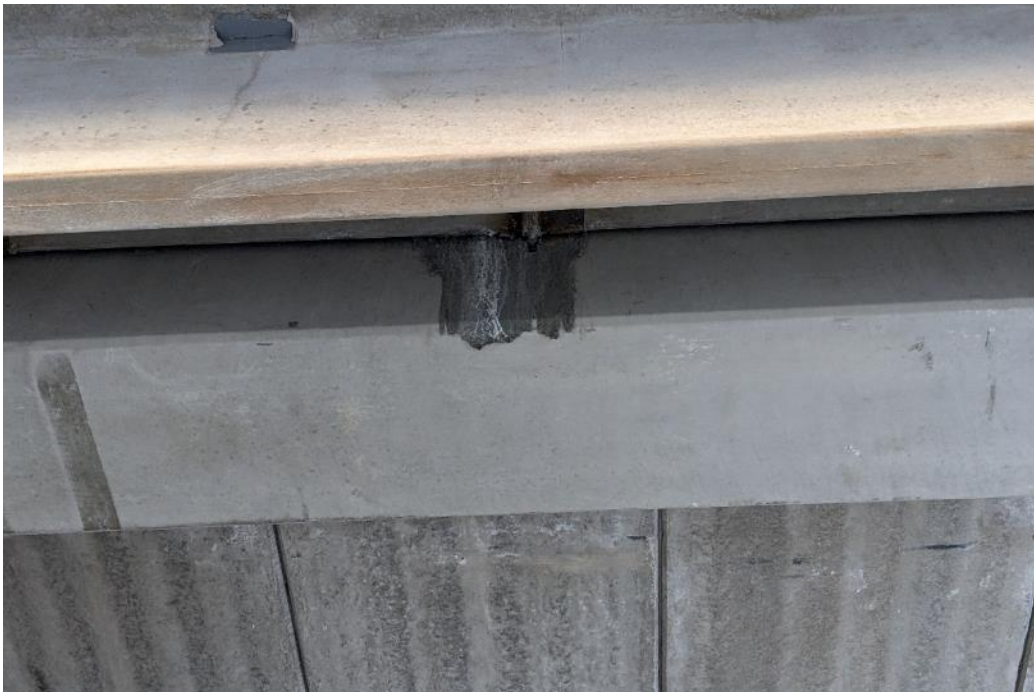
Photo 31. Typical water leakage and efflorescence at midspan shear connector in the finger.

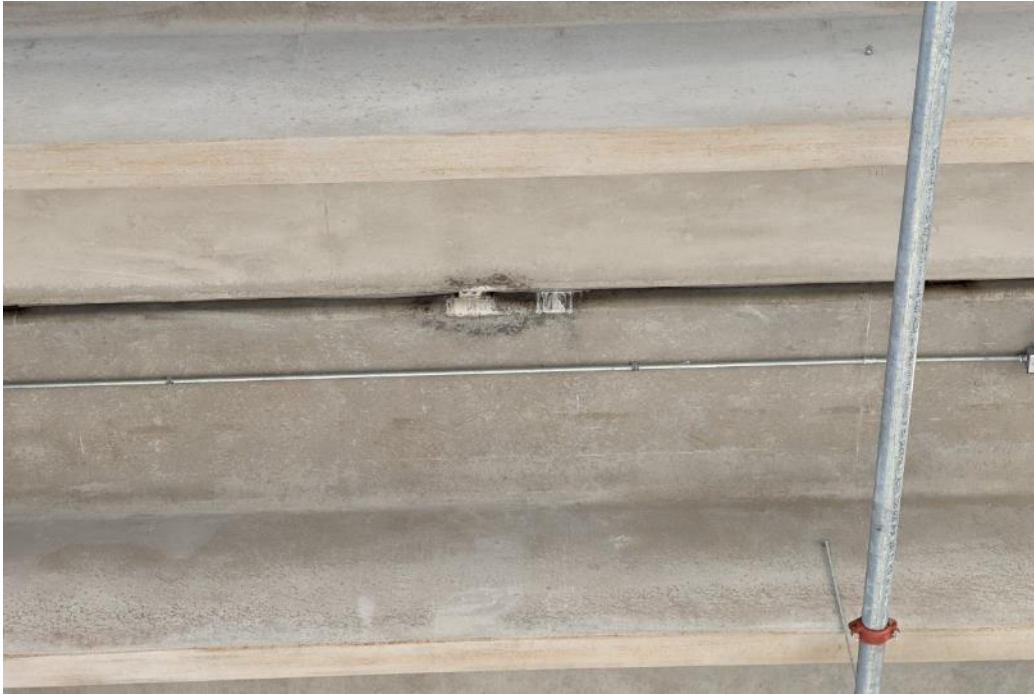
Photo 32. Typical water leakage and efflorescence at midspan shear connector in the finger.

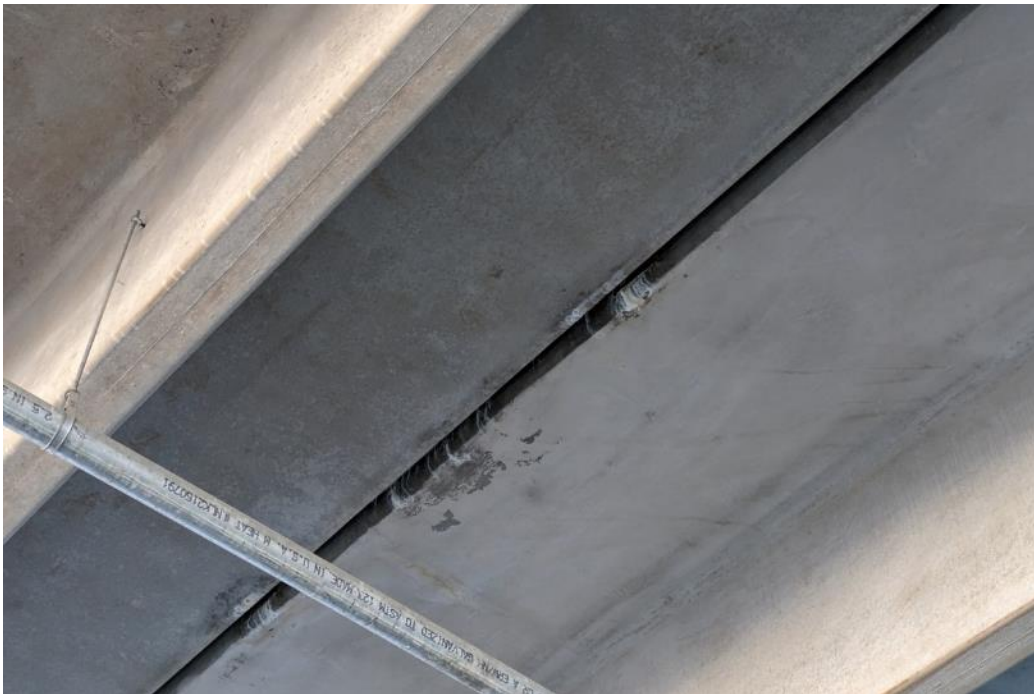
Photo 33. Water leakage and efflorescence from underneath a hollow core void.

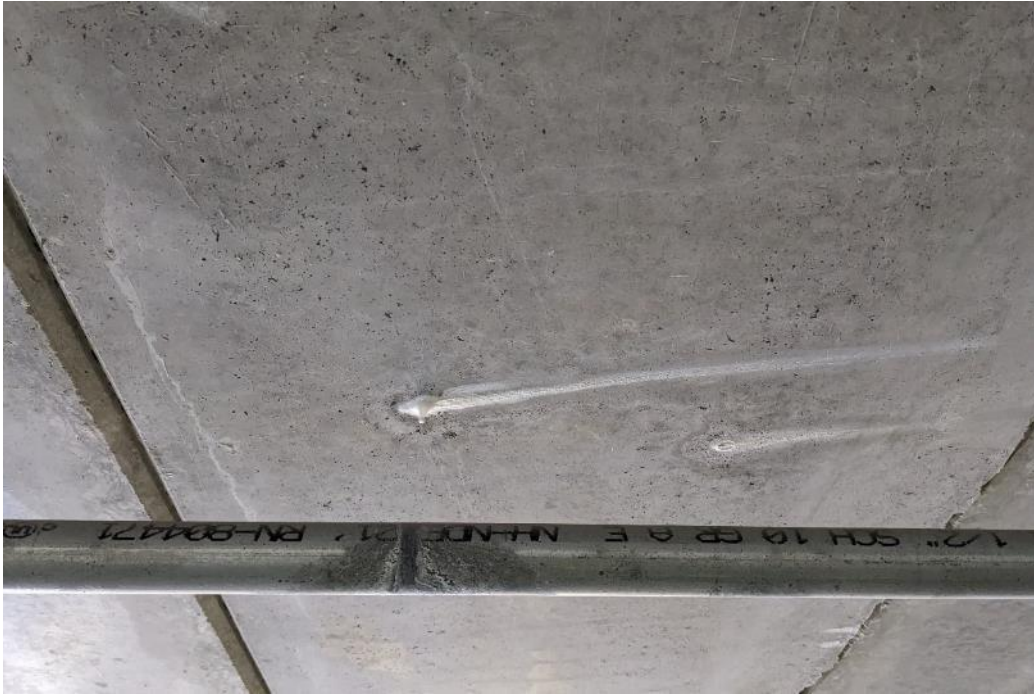
5. Water leakage and efflorescence was seen on the underside of a hollow core plank. The leaching appeared to come from the hollow core void (Photos 33 and 34).

Photo 34. Water leakage and efflorescence from underneath a hollow core void.

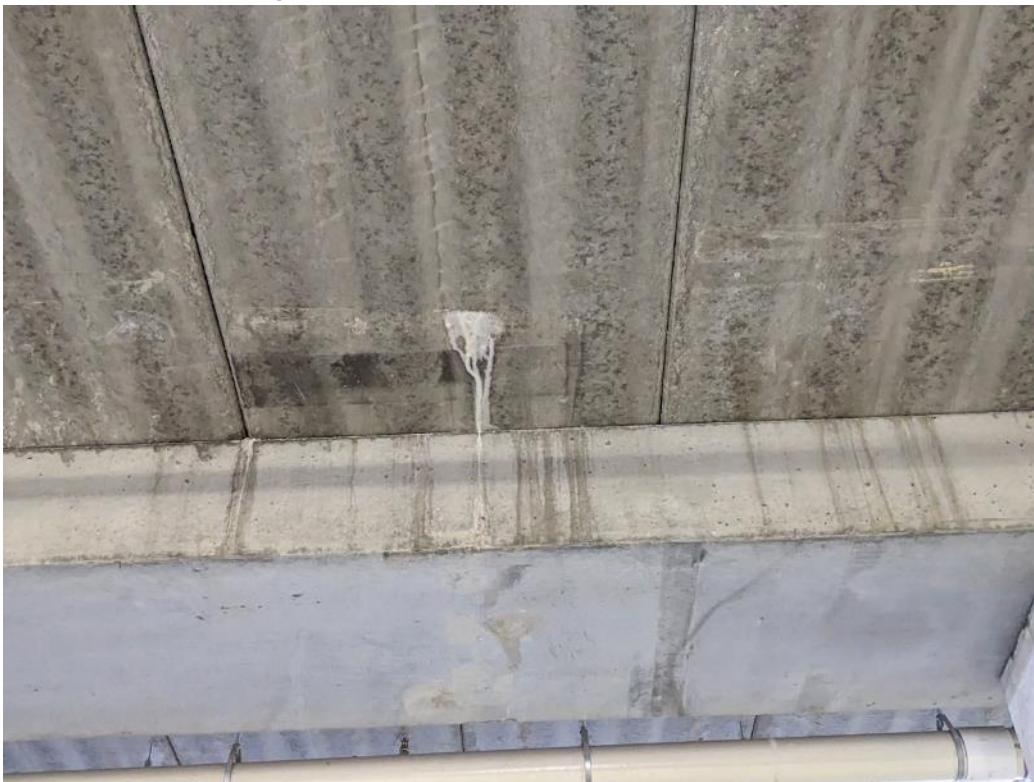
Photo 35. Overall view of a cracked hollow core plank.

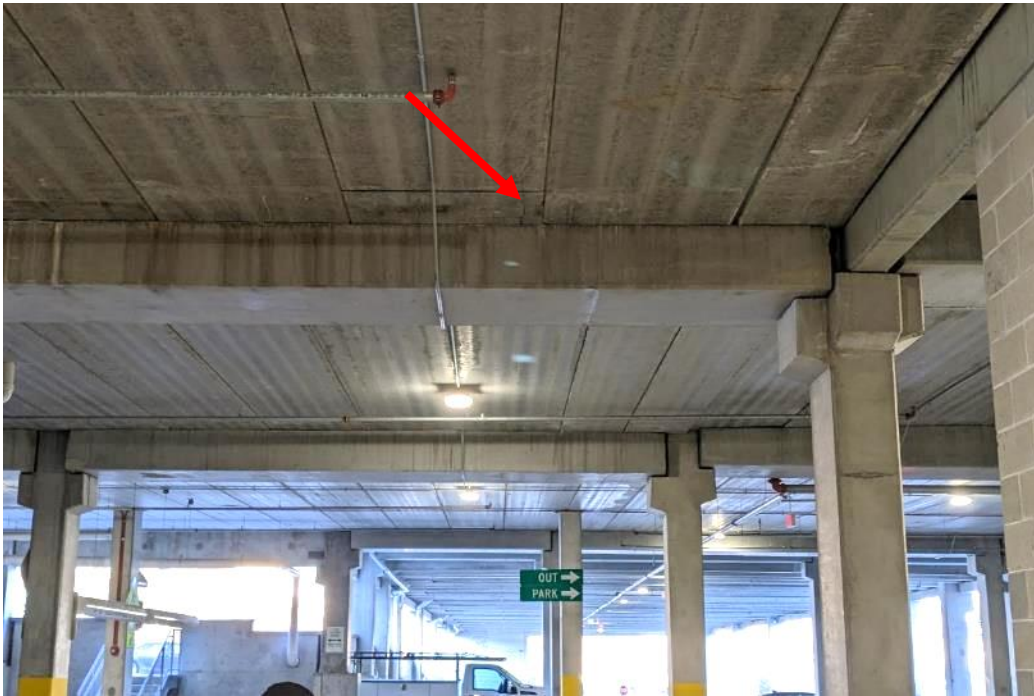
Photo 36. Close-up of the hollow core crack from the previous photo.

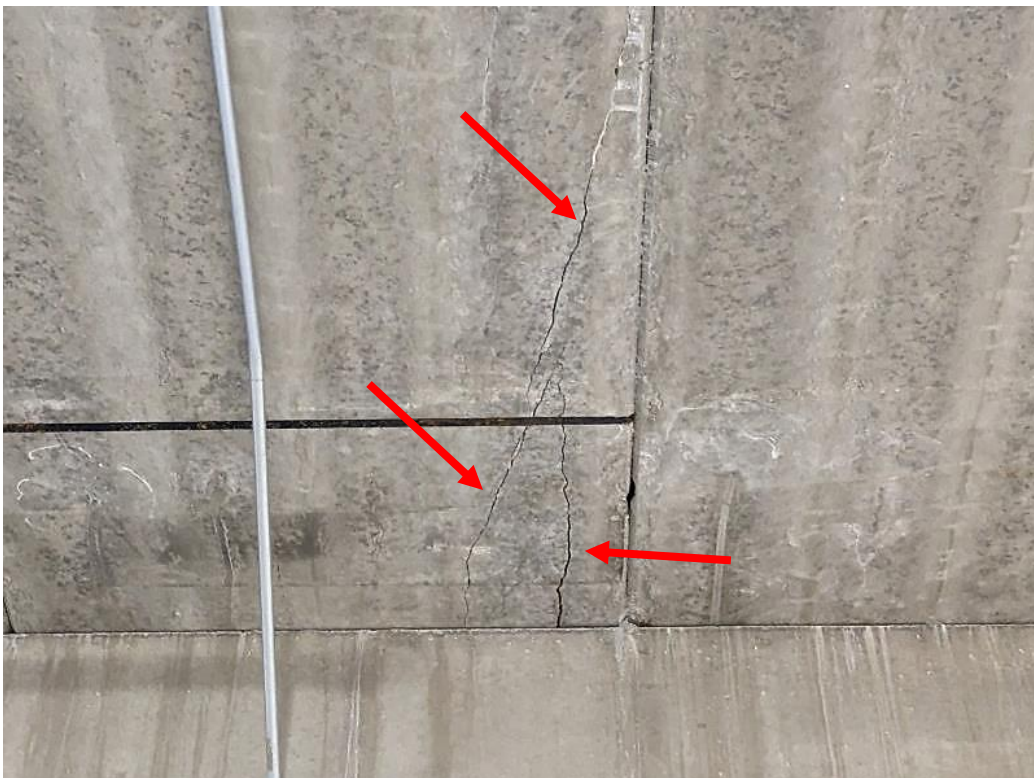
Photo 37. Overall view of a hollow core plank that has cracked.

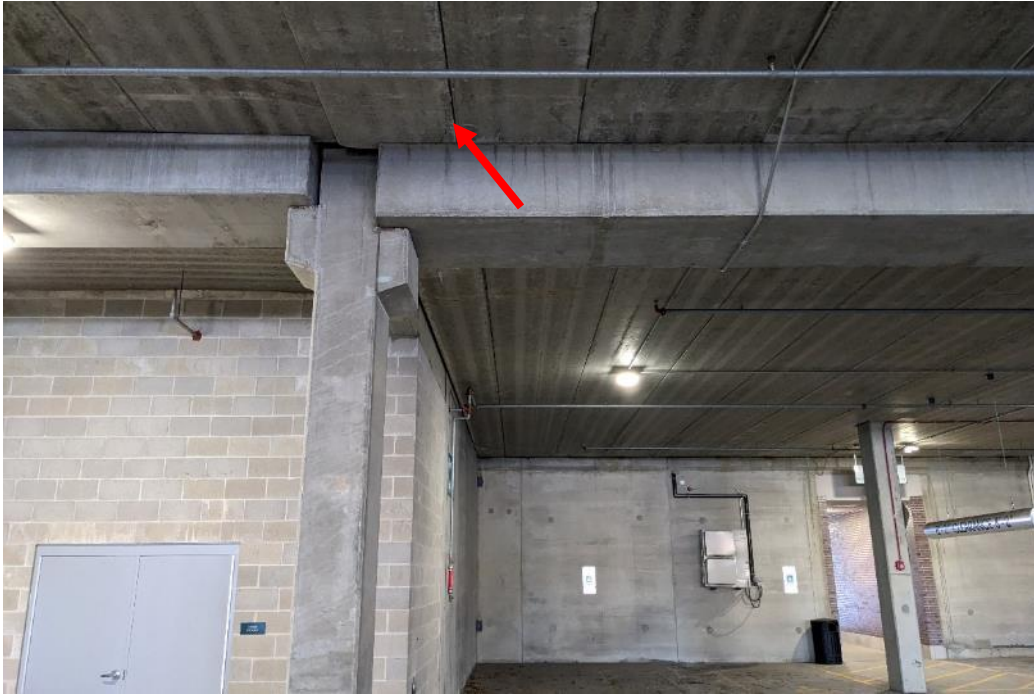
Photo 38. Close-up of the crack indicated in the previous photo.

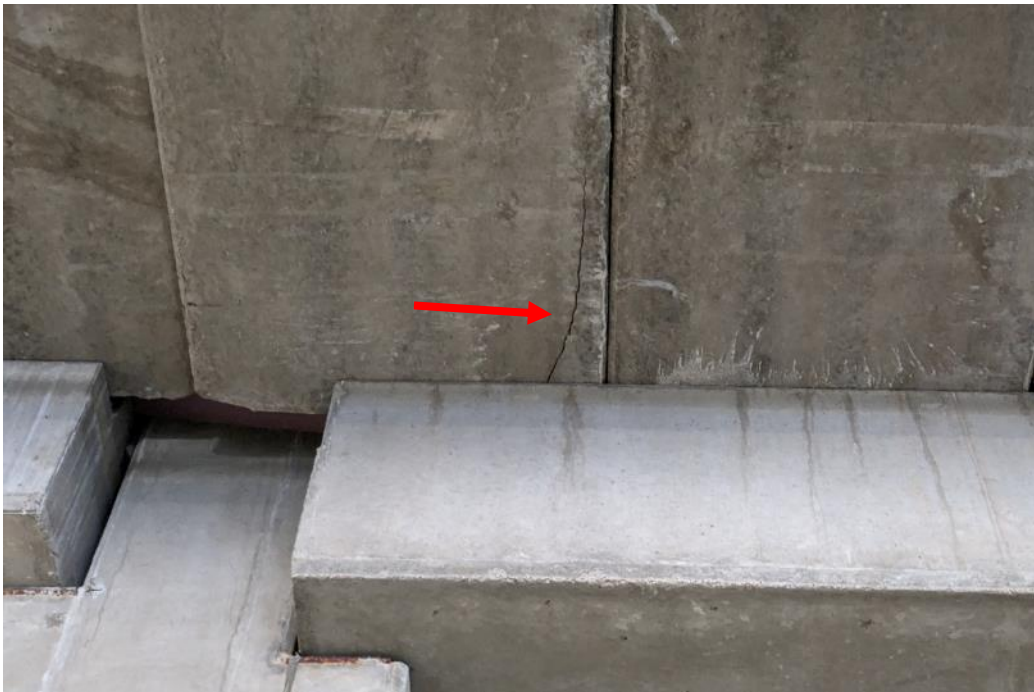
Photo 39. A hollow core plank with a crack near the supported end.

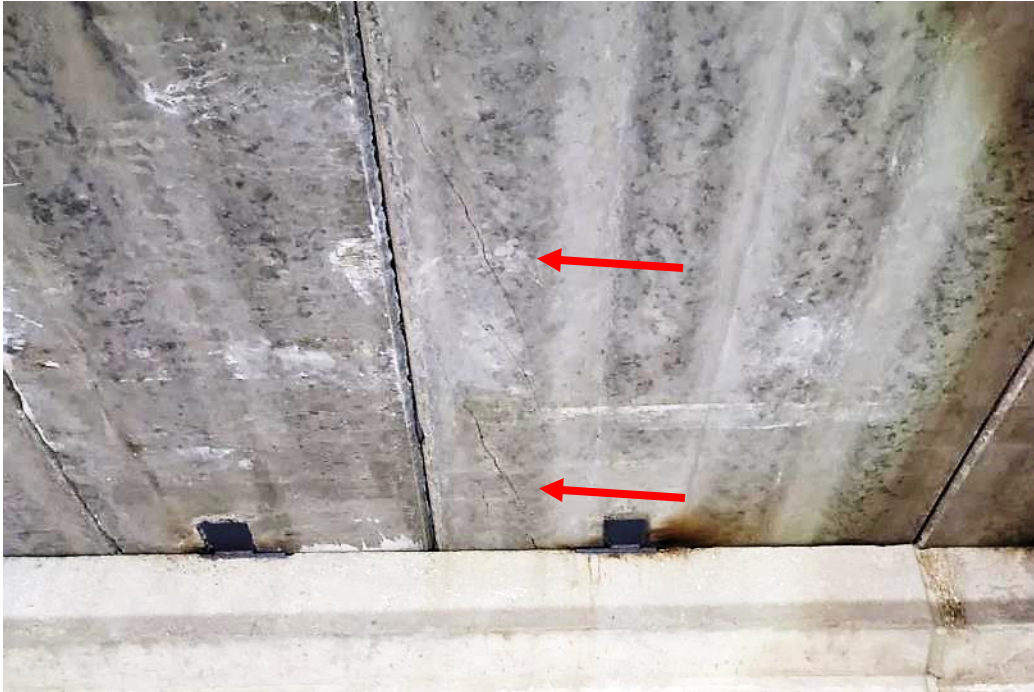
Photo 40. Another crack on a hollow core plank with efflorescence.

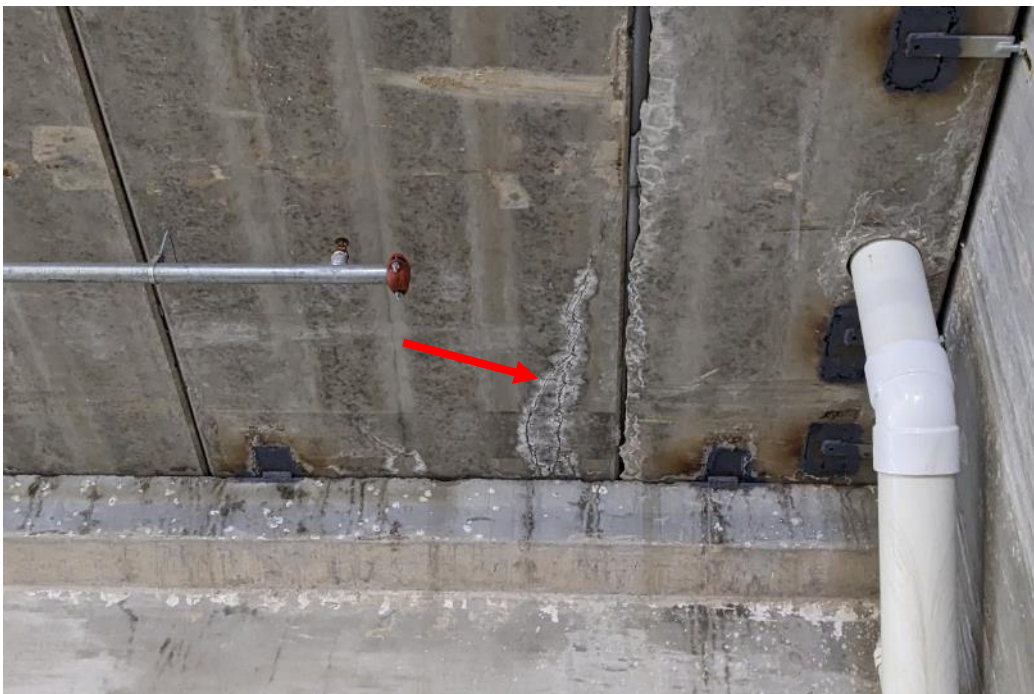
Photo 41. Concrete spall at the end of the inverted tee beam along Grid 4.

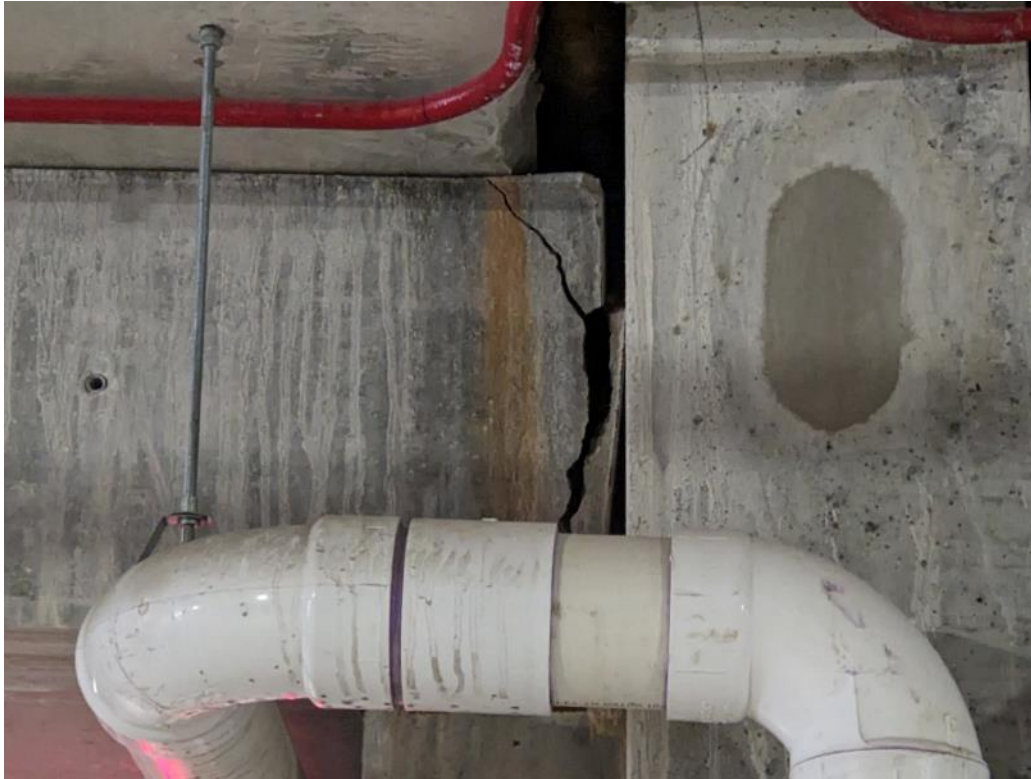
Photo 42. A small delamination of a beam haunch between hollow core planks along Grid Line 1.

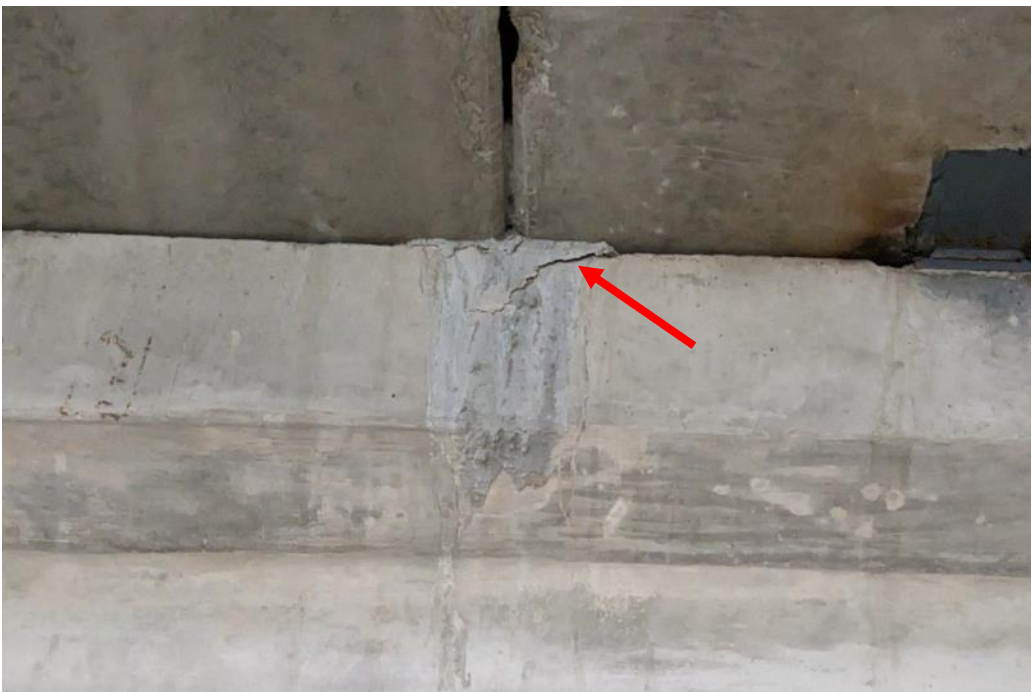
9. A large concrete delamination with corrosion staining was observed in the L-beam supporting the double-tees in the finger near the west entrance (Photo 43).

Photo 43. A delaminated concrete L-beam with corrosion staining near the west entrance in the finger.

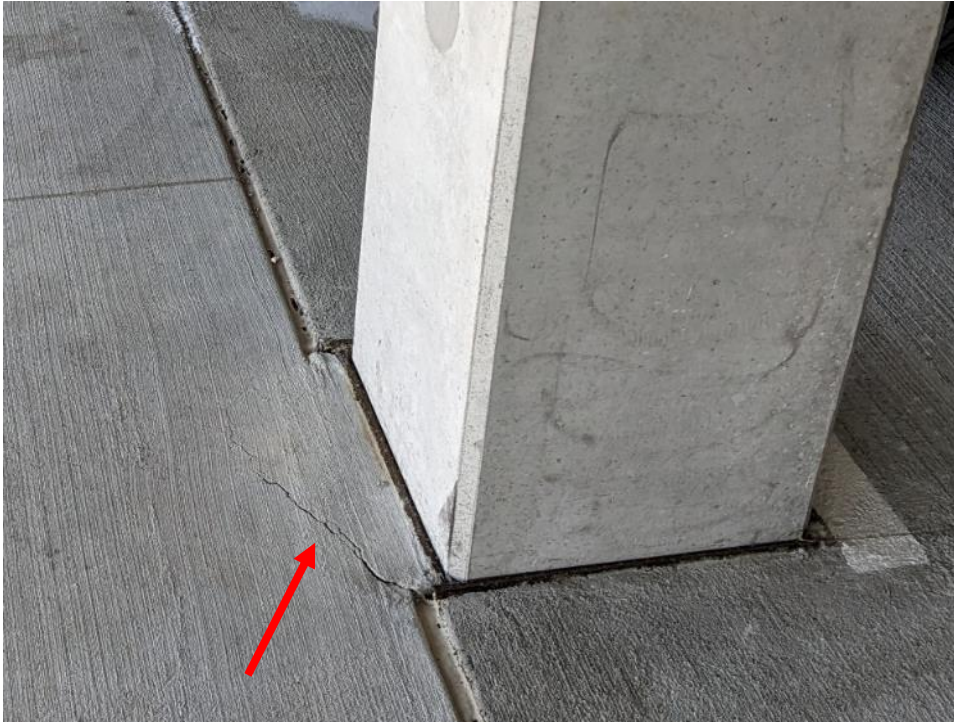
Photo 50. Overall view of a wide crack that extends from wall to column to shear wall.

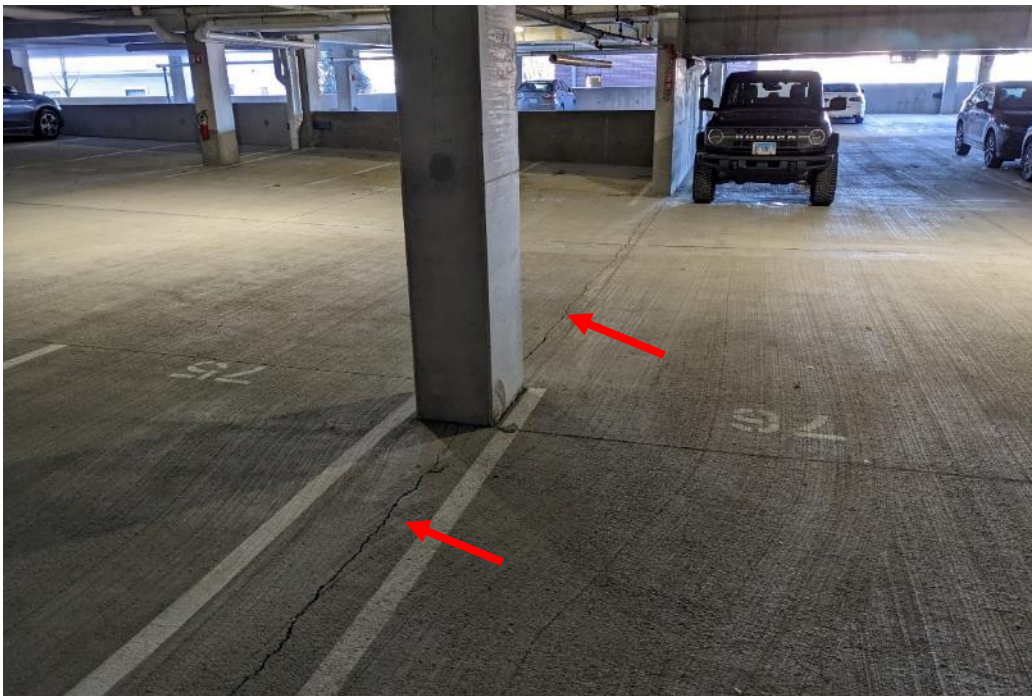
Photo 51. A wide crack on the floor between the wall and column.

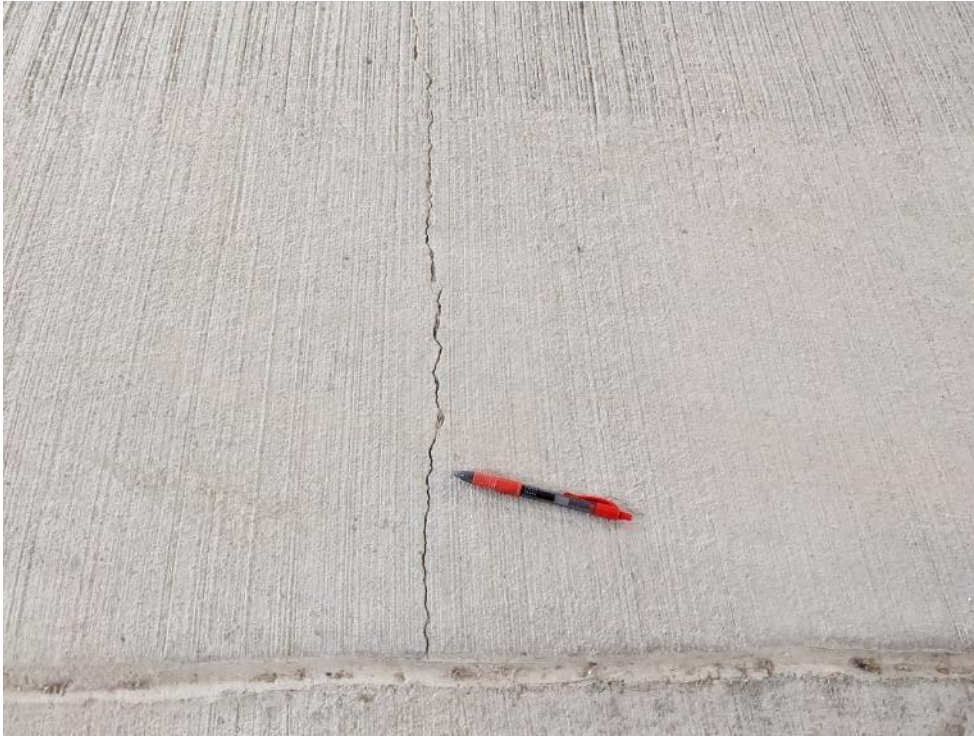
Photo 54. Typical crack in 2<sup>nd</sup> level floor topping slab perpendicular to the hollow core planks.

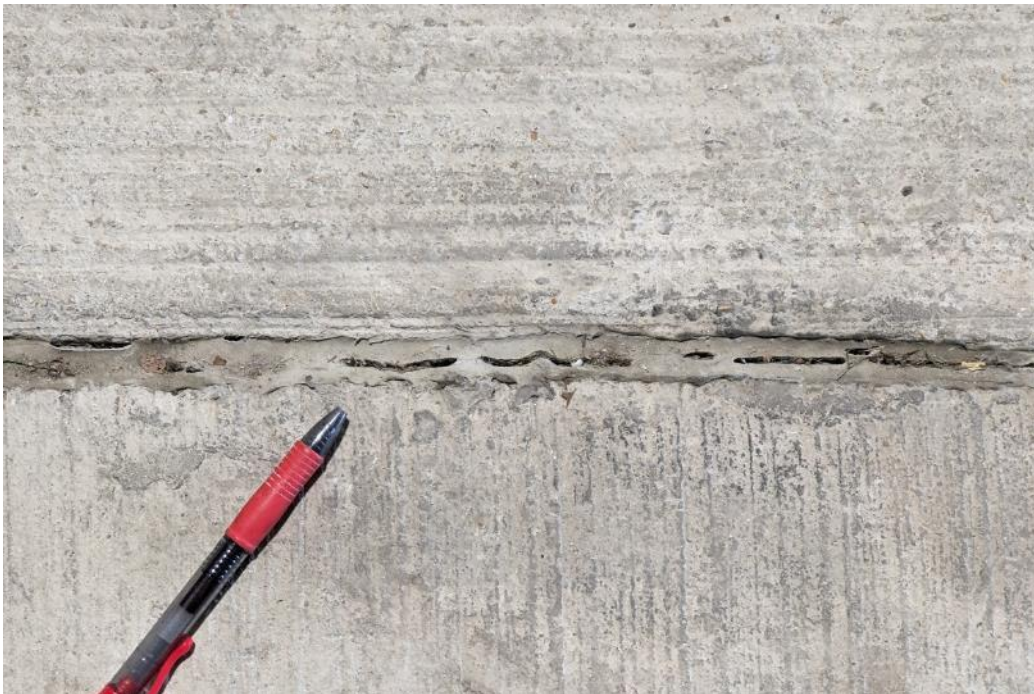
Photo 59. Failed construction joint sealant above the beam that separates the finger from the main structure.

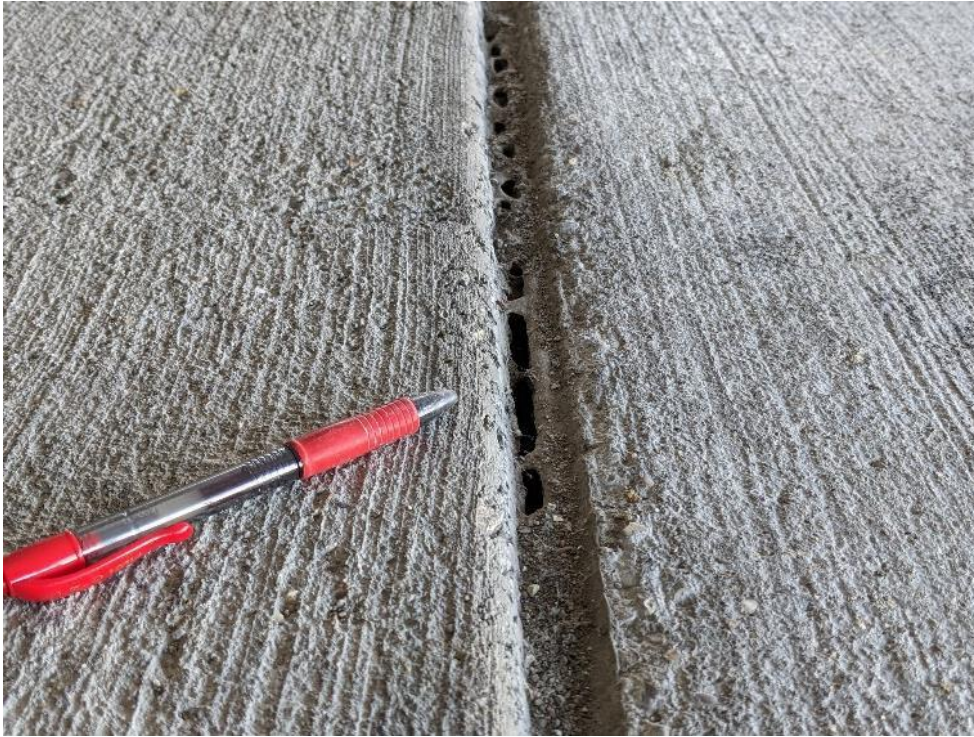
Photo 60. Additional failed construction joint sealant.

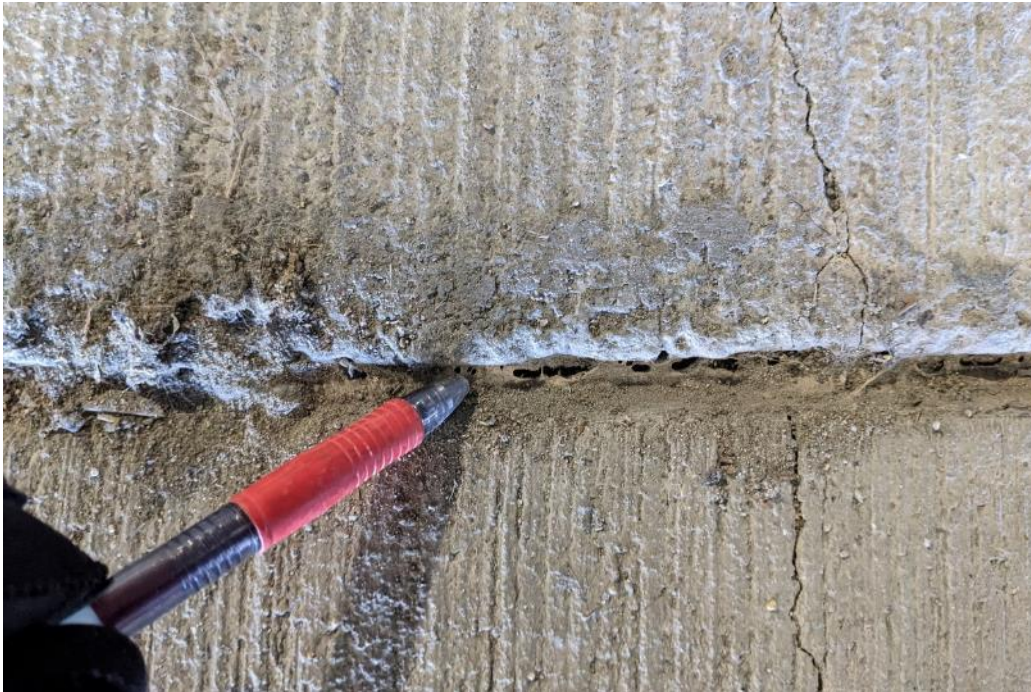
Photo 61. Additional failed construction joint sealant.

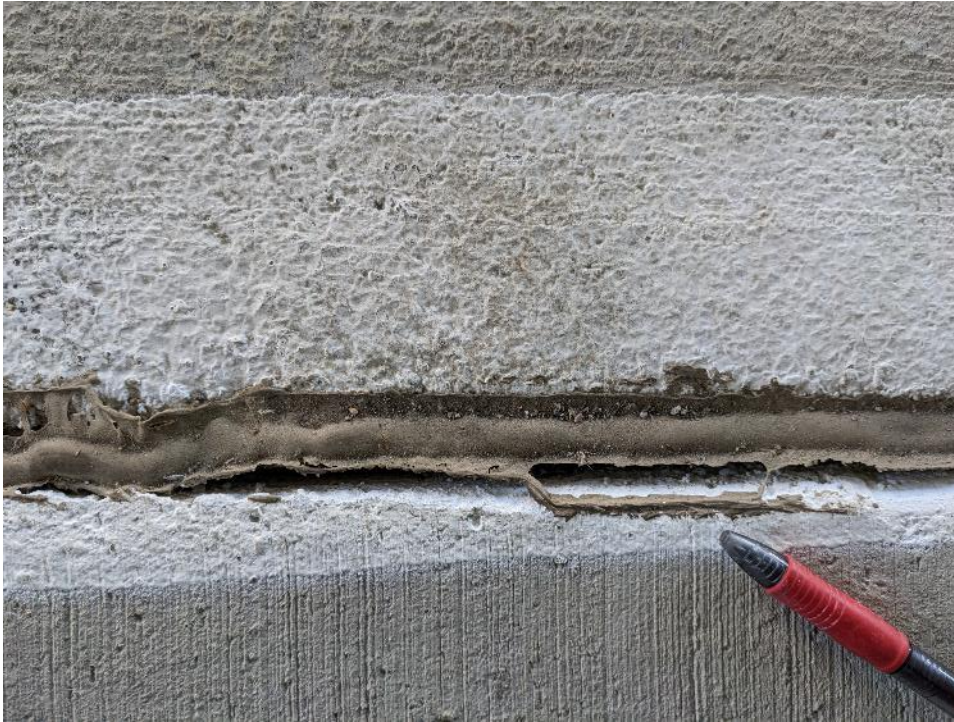
Photo 62. Cove sealant at the wall bases was typically missing at areas except at limited areas at the south end.

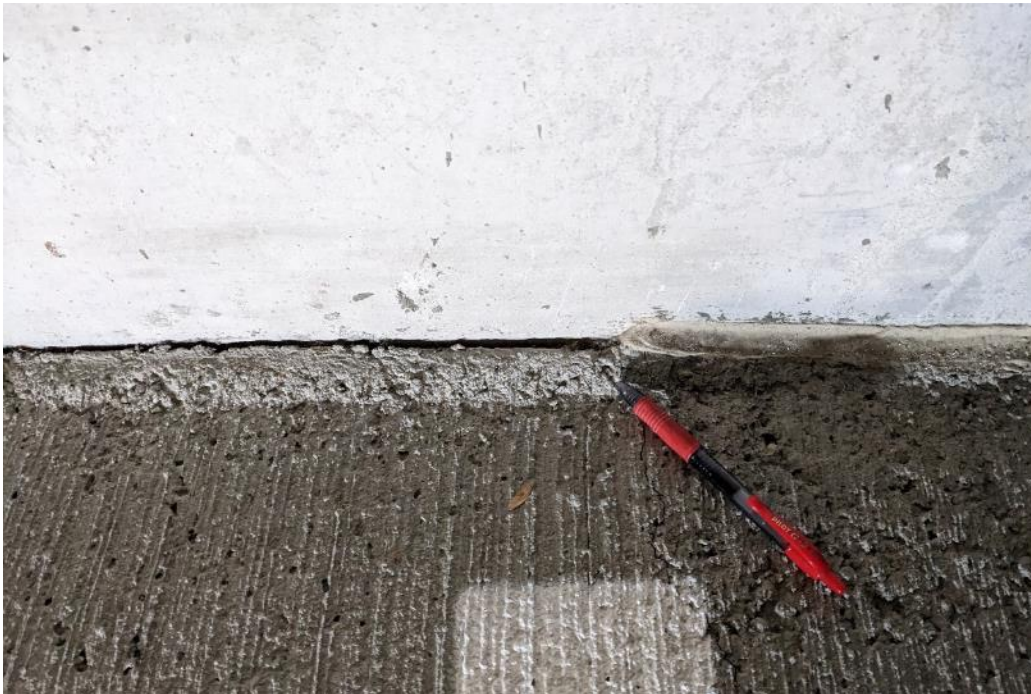
Photo 63. Shear walls typically missing cove sealant along the base. Also note failed control joint sealant.
