Agenda  
Village of Glen Ellyn  
Special Village Board Workshop  
Monday, September 9, 2024  
6:00 PM  
Glen Ellyn Civic Center, Room 301

## **Discussion of the Acceptance of the Public Improvements for the Main Street Garage**

At the request of the Village of Glen Ellyn, Walker Consultants performed a Visual Review of the 400 Apex Parking Facility in Glen Ellyn, Illinois. The objectives of this Condition Assessment were to perform a visual review of the parking facility's readily observable structural and waterproofing systems to identify current distress and/or deterioration.

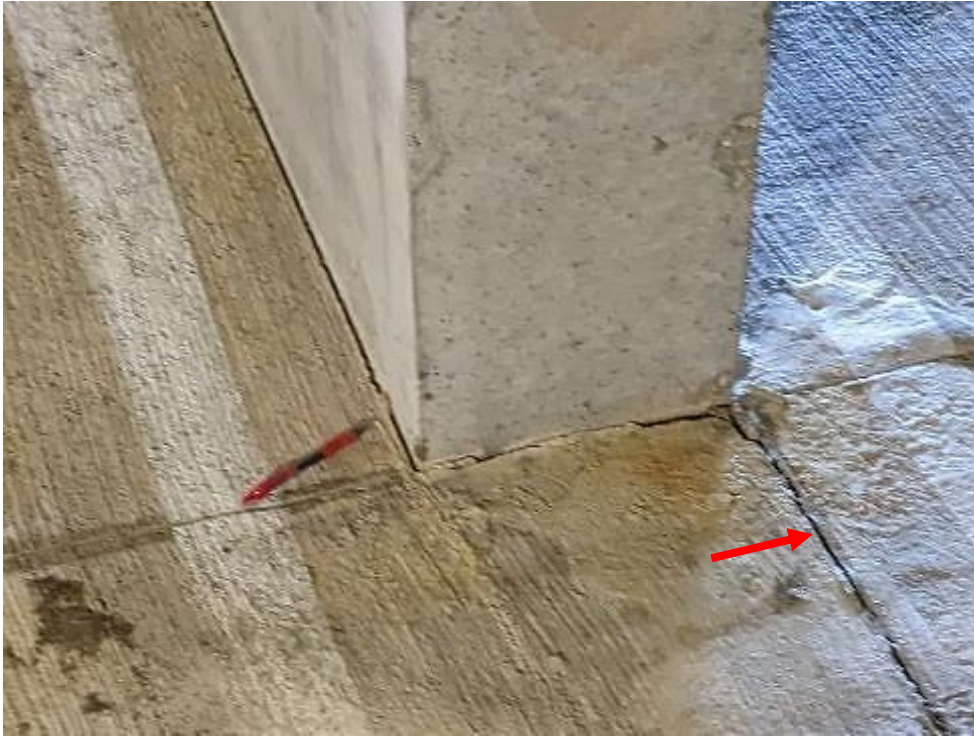
Photo 64. Cove sealant was typically missing at the column bases.

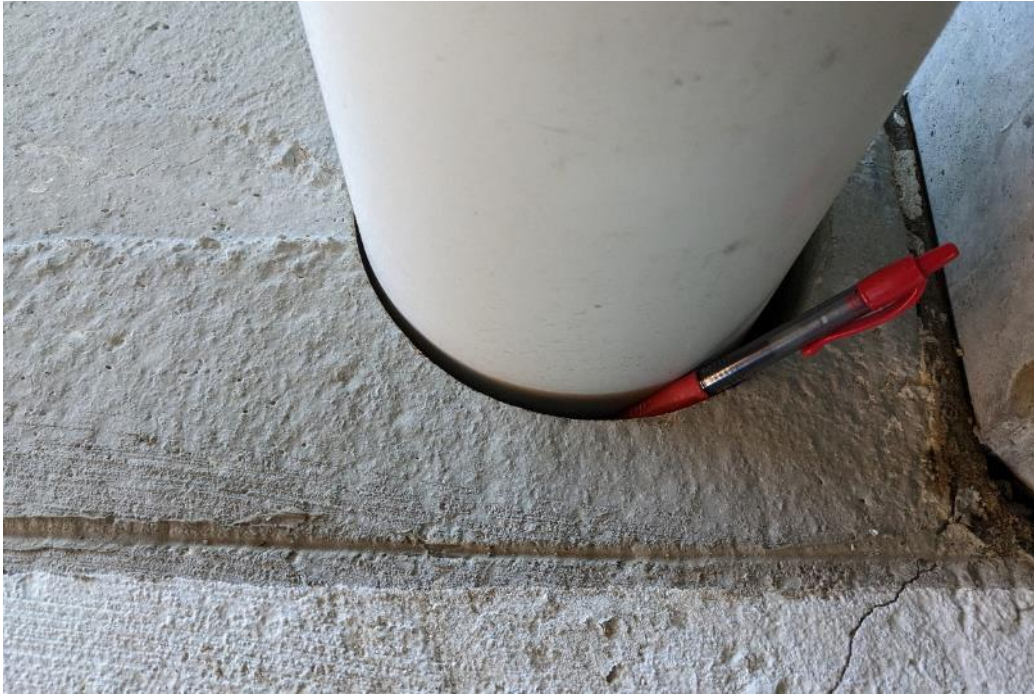
Photo 66. Pipe penetrations were typically not sealed. Also note floor crack extending from pipe penetration.

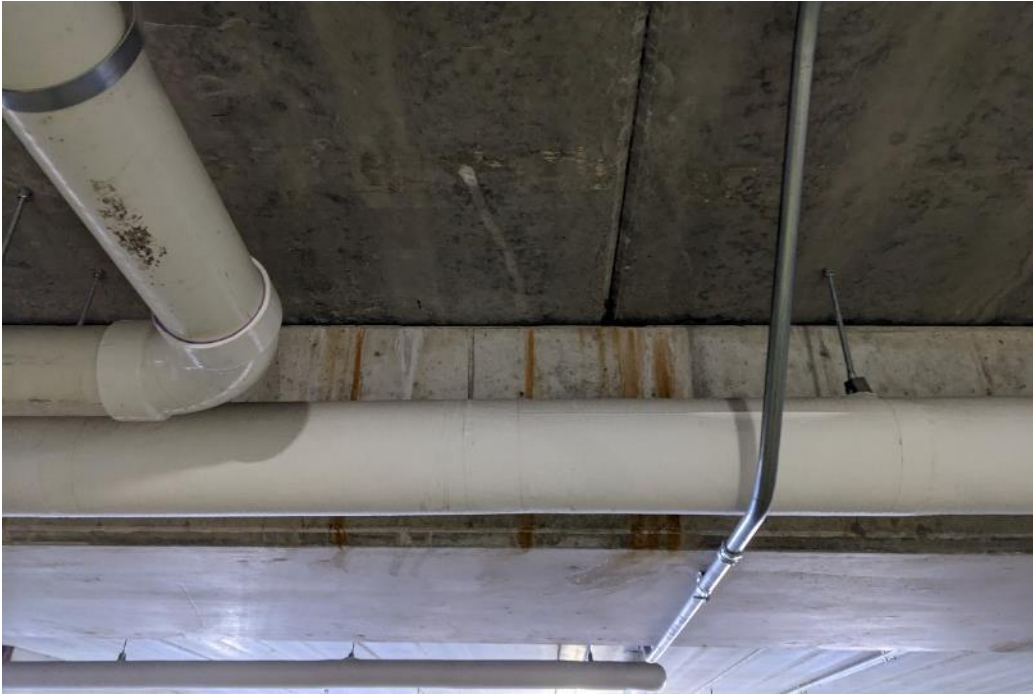
Photo 68. Corrosion staining along the length of a beam observed from the 2<sup>nd</sup> floor.

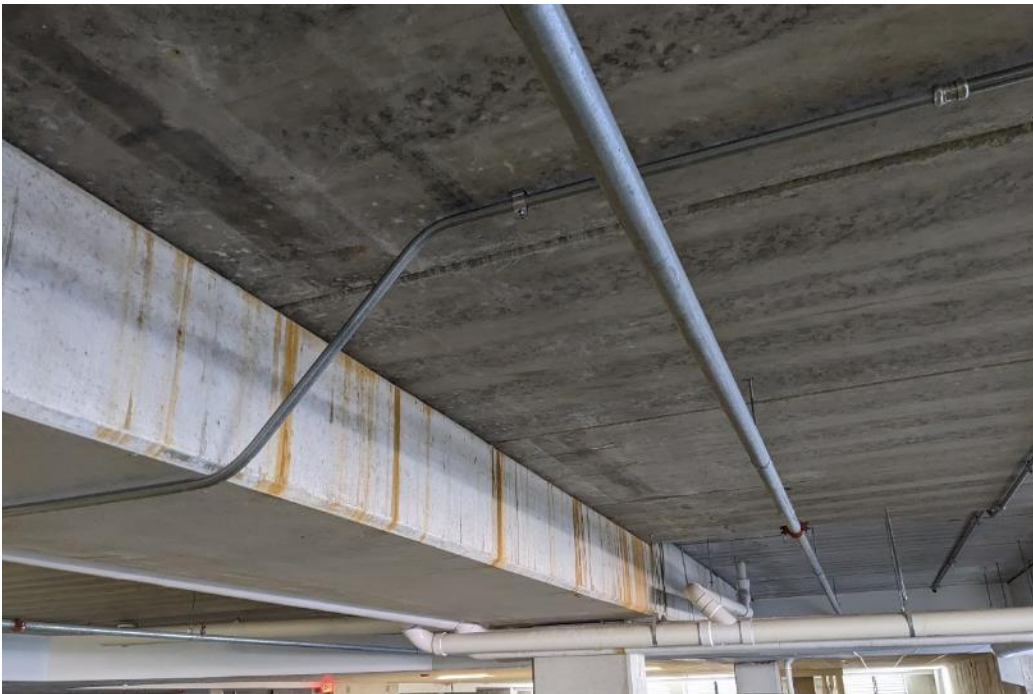
Photo 69. Heavy staining on a deep beam spanning between shear walls observed from the 2<sup>nd</sup> floor.

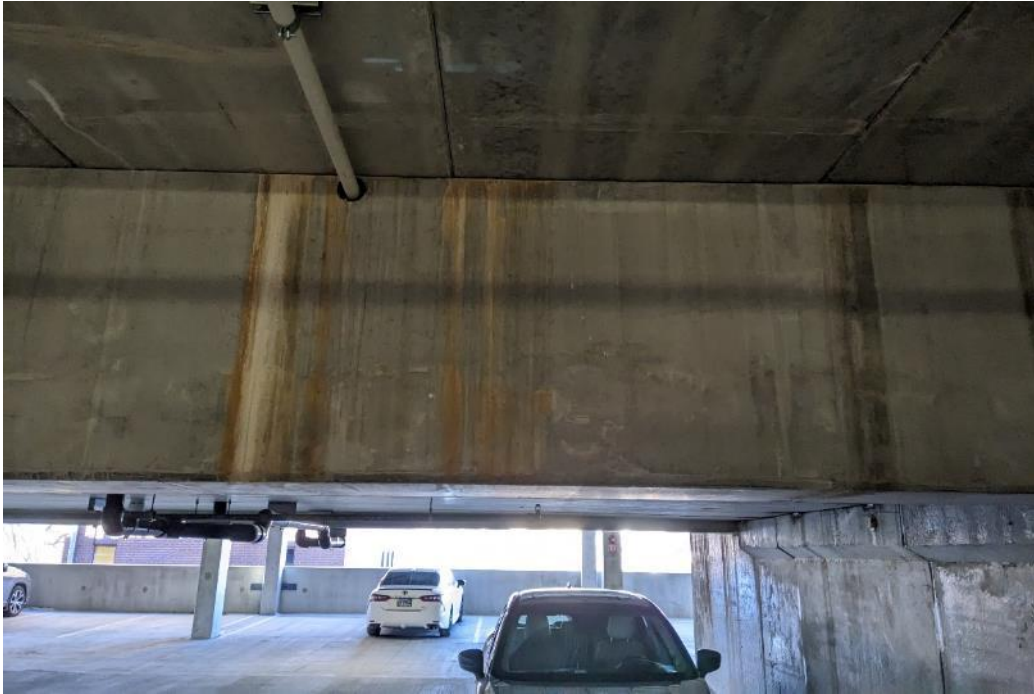
Photo 70. Active leaking observed on underside of 3<sup>rd</sup> level hollow core void into the parking area.

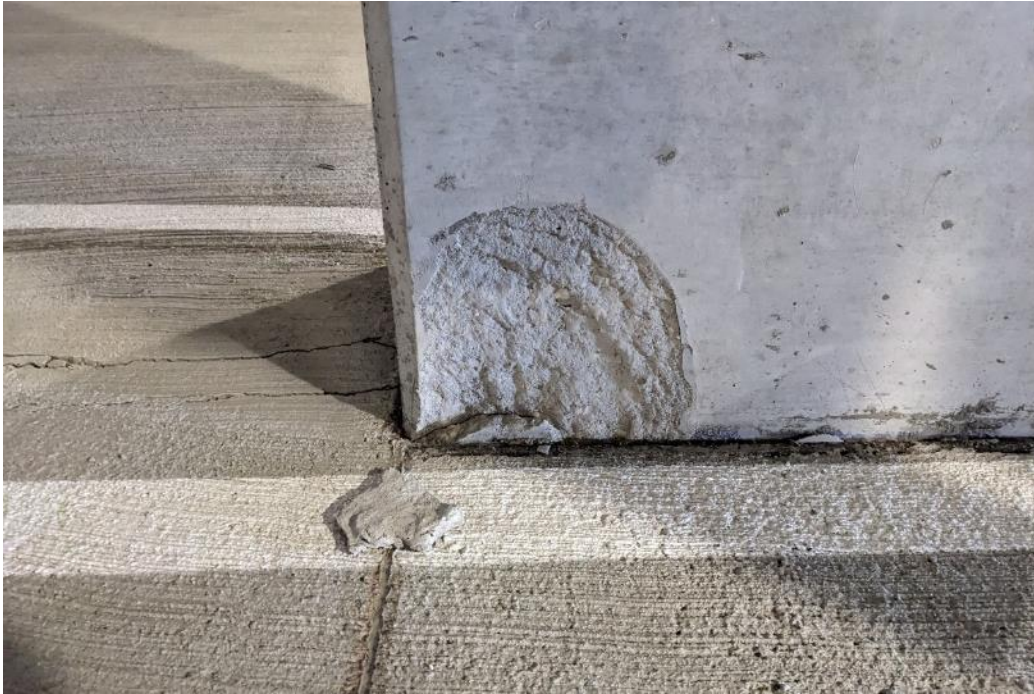
Photo 72. An isolated concrete column delamination on the interior surface.

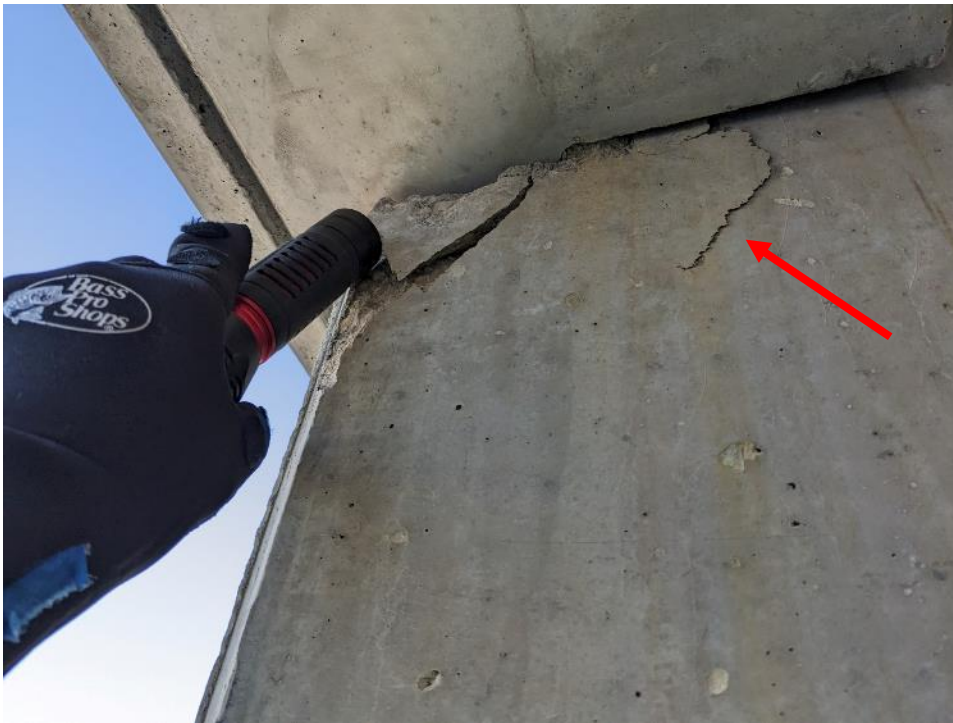
Photo 73. An isolated concrete column spall at 2<sup>nd</sup> level.
