Agenda  
Village of Glen Ellyn  
Special Workshop Meeting  
Monday, September 18, 2017  
7:00 PM  
Police Department Community Room

## **Staff will lead a discussion pertaining to traffic related issues occurring at the intersection of Lambert and Taft**

## Memorandum

**Re:** Lambert Road & Taft Avenue – Traffic Safety Study

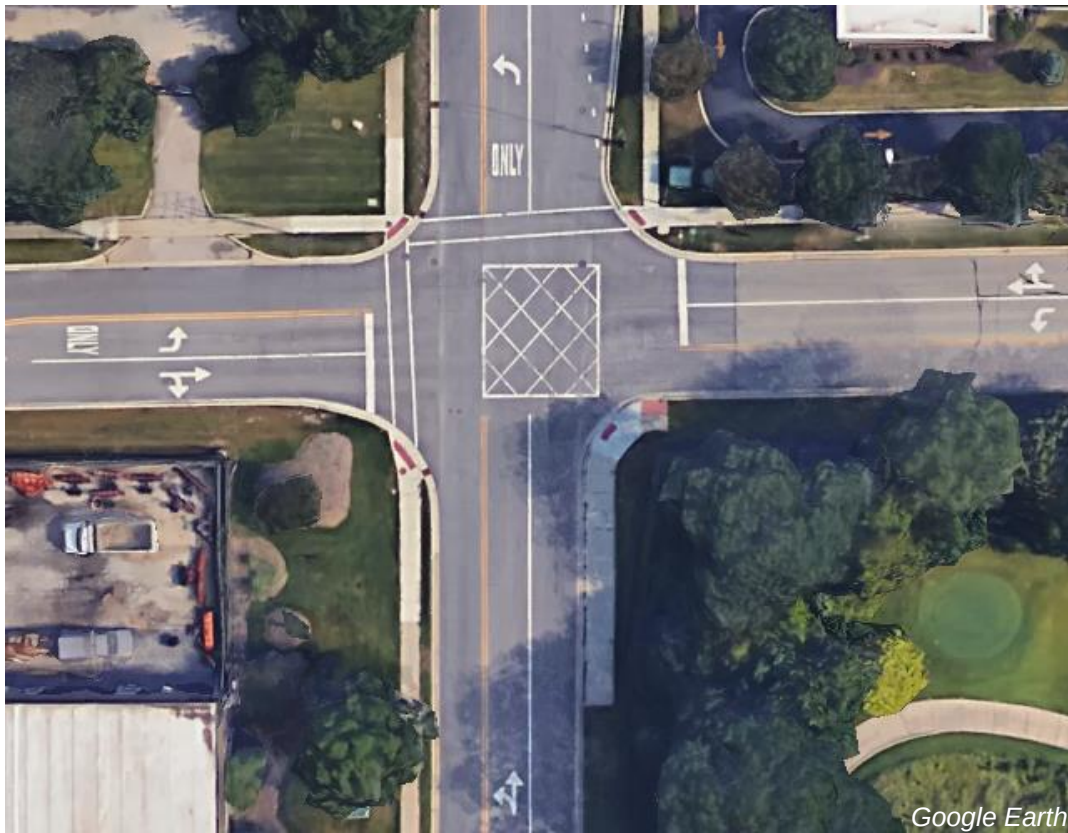
The intersection of Lambert Road & Taft Avenue is two-way stop controlled, with stop signs on the Taft Avenue approaches. As stated above, the intersection is located approximately 300 feet south of the IL Route 38 & Lambert Road intersection, which is controlled by a traffic signal. The east- and westbound Taft Avenue approaches each have one exclusive left-turn lane and one shared through/right-turn lane. Southbound Lambert Road has one shared left-turn/through/right-turn lane. Northbound Lambert Road has one shared through/left-turn lane and one shared through/right-turn lane. The through/left-turn lane feeds directly into the northbound left-turn lane for the IL Route 38 & Lambert Road intersection. The close proximity to IL Route 38 essentially turns the northbound through/left-turn lane approaching Taft Avenue into additional storage for the northbound left-turn at IL Route 38. The middle of the intersection is cross-hatched to keep motorists from stopping within the intersection while queued for the IL Route 38 & Lambert Road traffic signal. An aerial image of the intersection is shown on the following page.

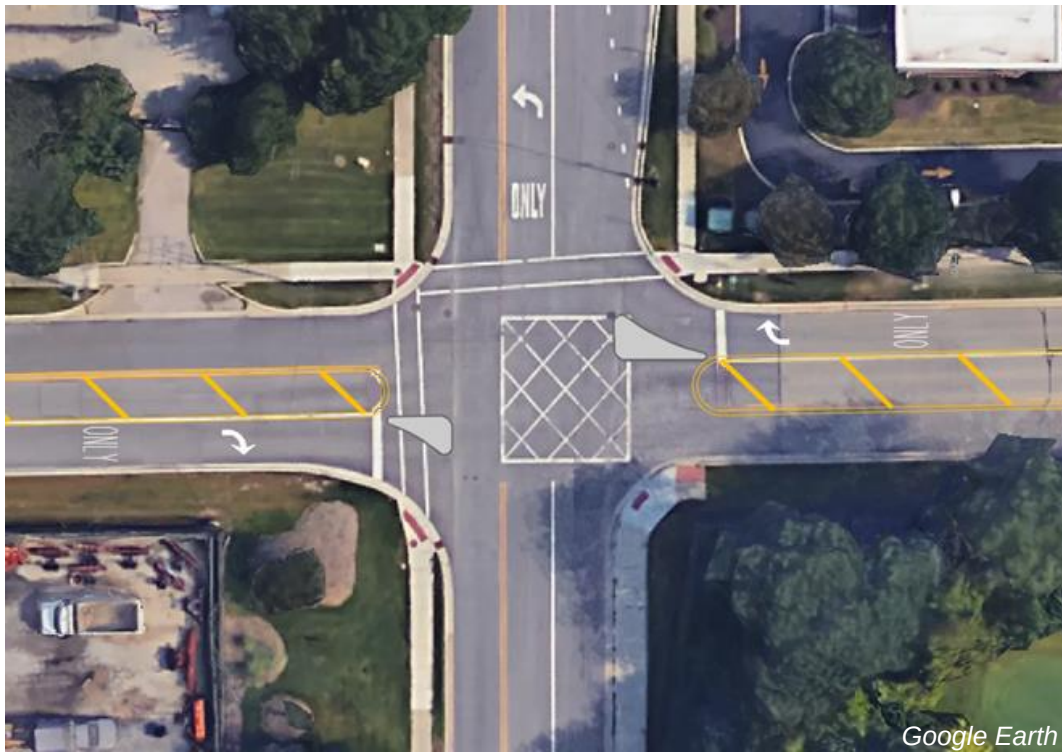
Restricting the movements most involved in the crashes is a good way to improve the safety of the intersection. Since the majority of the crashes involve eastbound and westbound through movements, restricting these would greatly reduce the crash rate of the intersection. Placing islands on the east- and westbound approaches would still allow right-turn movements from Taft Avenue and right-turns and left-turns from the Lambert Road approaches. A concept of this is shown on the following page.

With the limited traffic data at this time, the installation of movement restricting islands at the intersection which restrict through and left-turn movements from Taft Avenue appears to have the greatest potential to reduce crashes. By restricting the movements most commonly involved in crashes, this will have a significant impact on the number of crashes at this intersection. Traffic counts should be taken and analyzed to ensure that restricting these movements does not have a significant negative effect on traffic operations or businesses in the area.

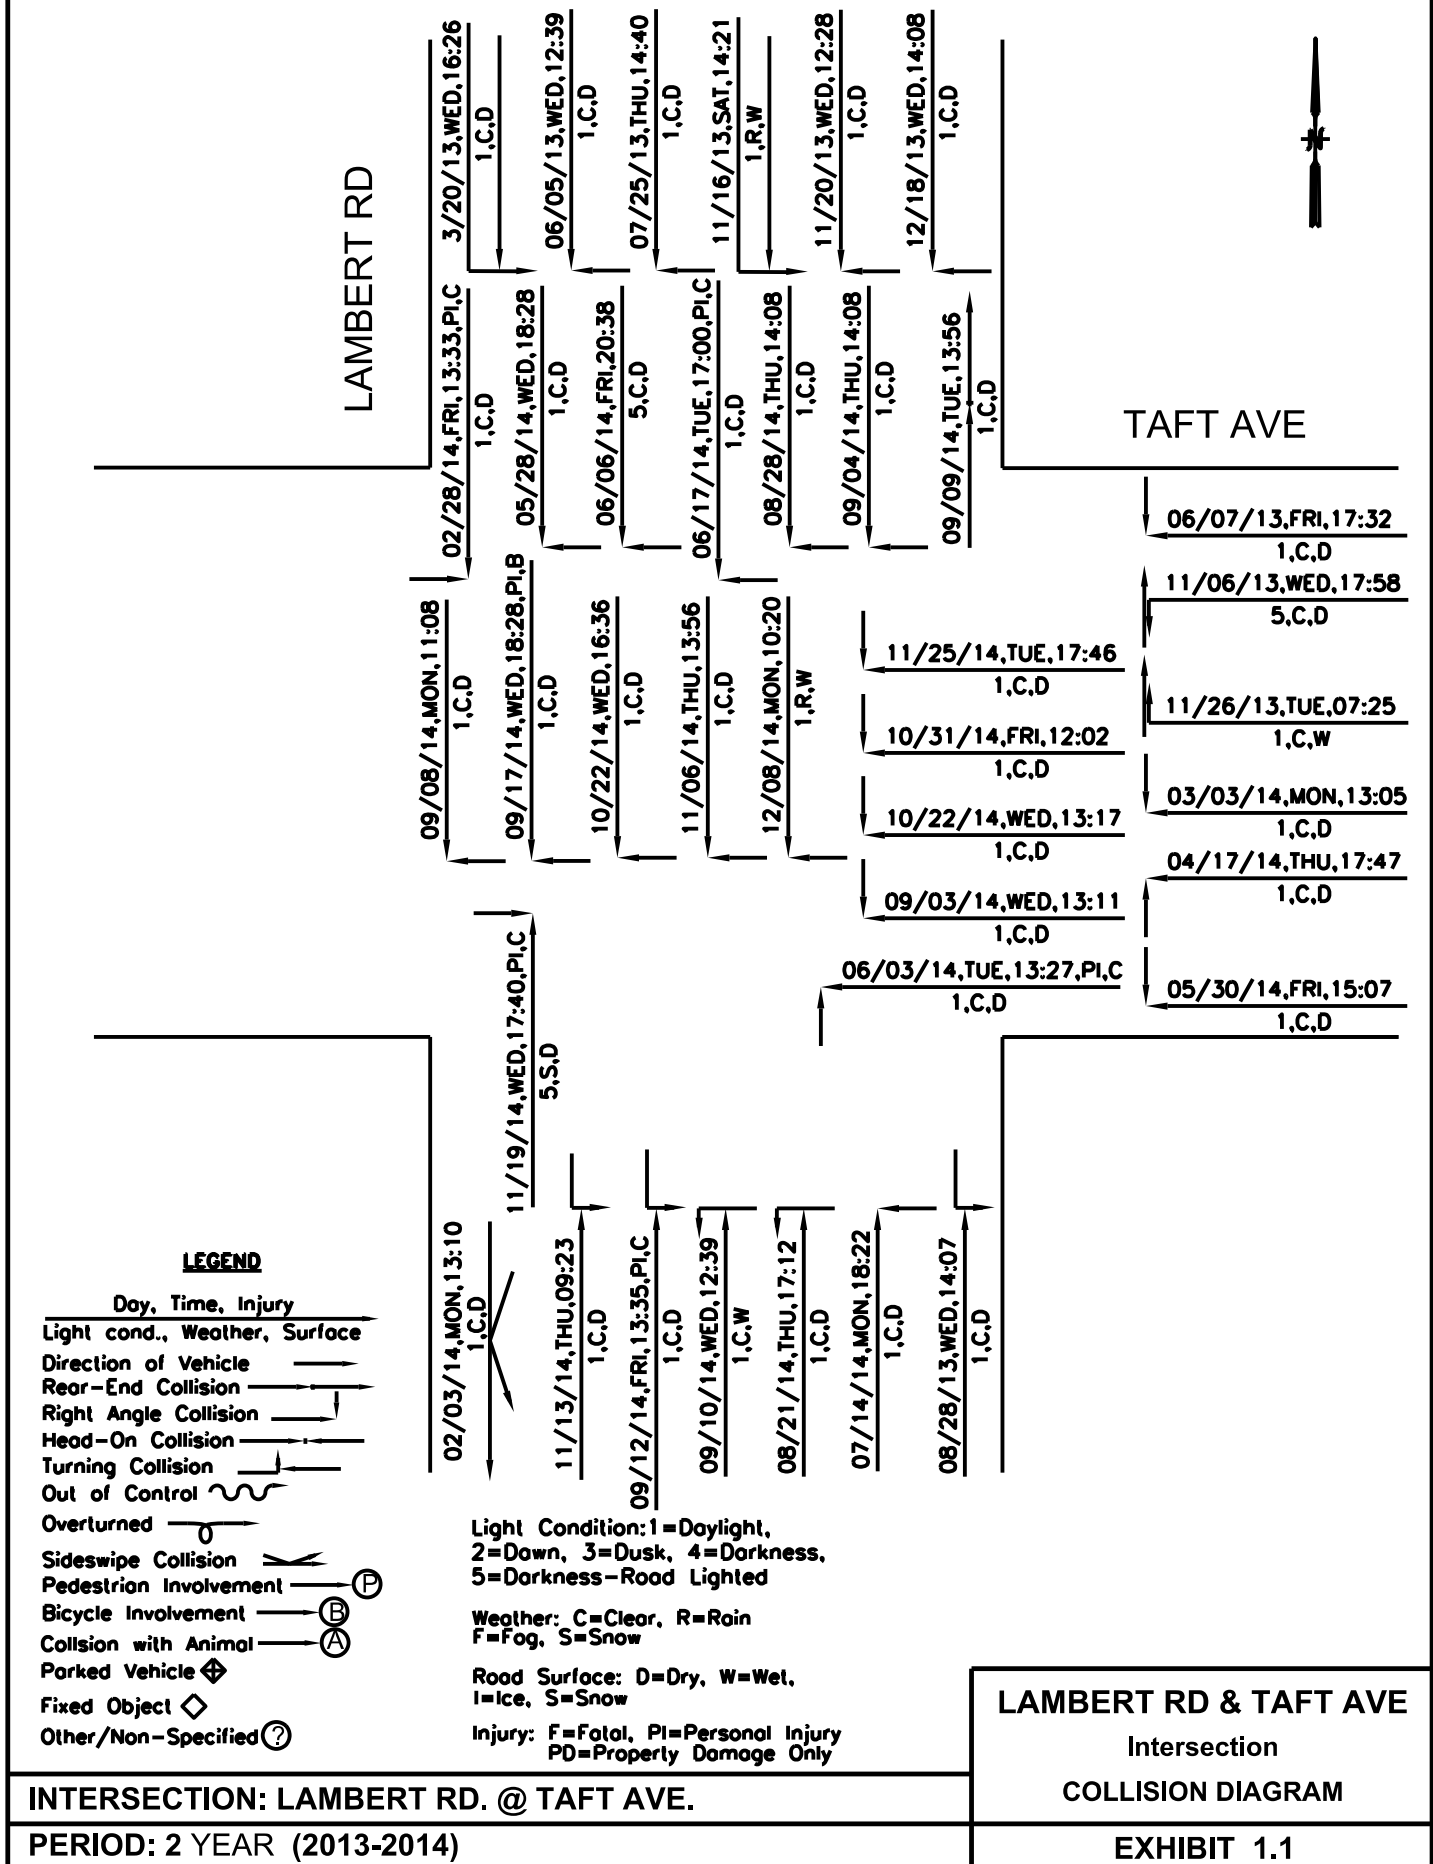
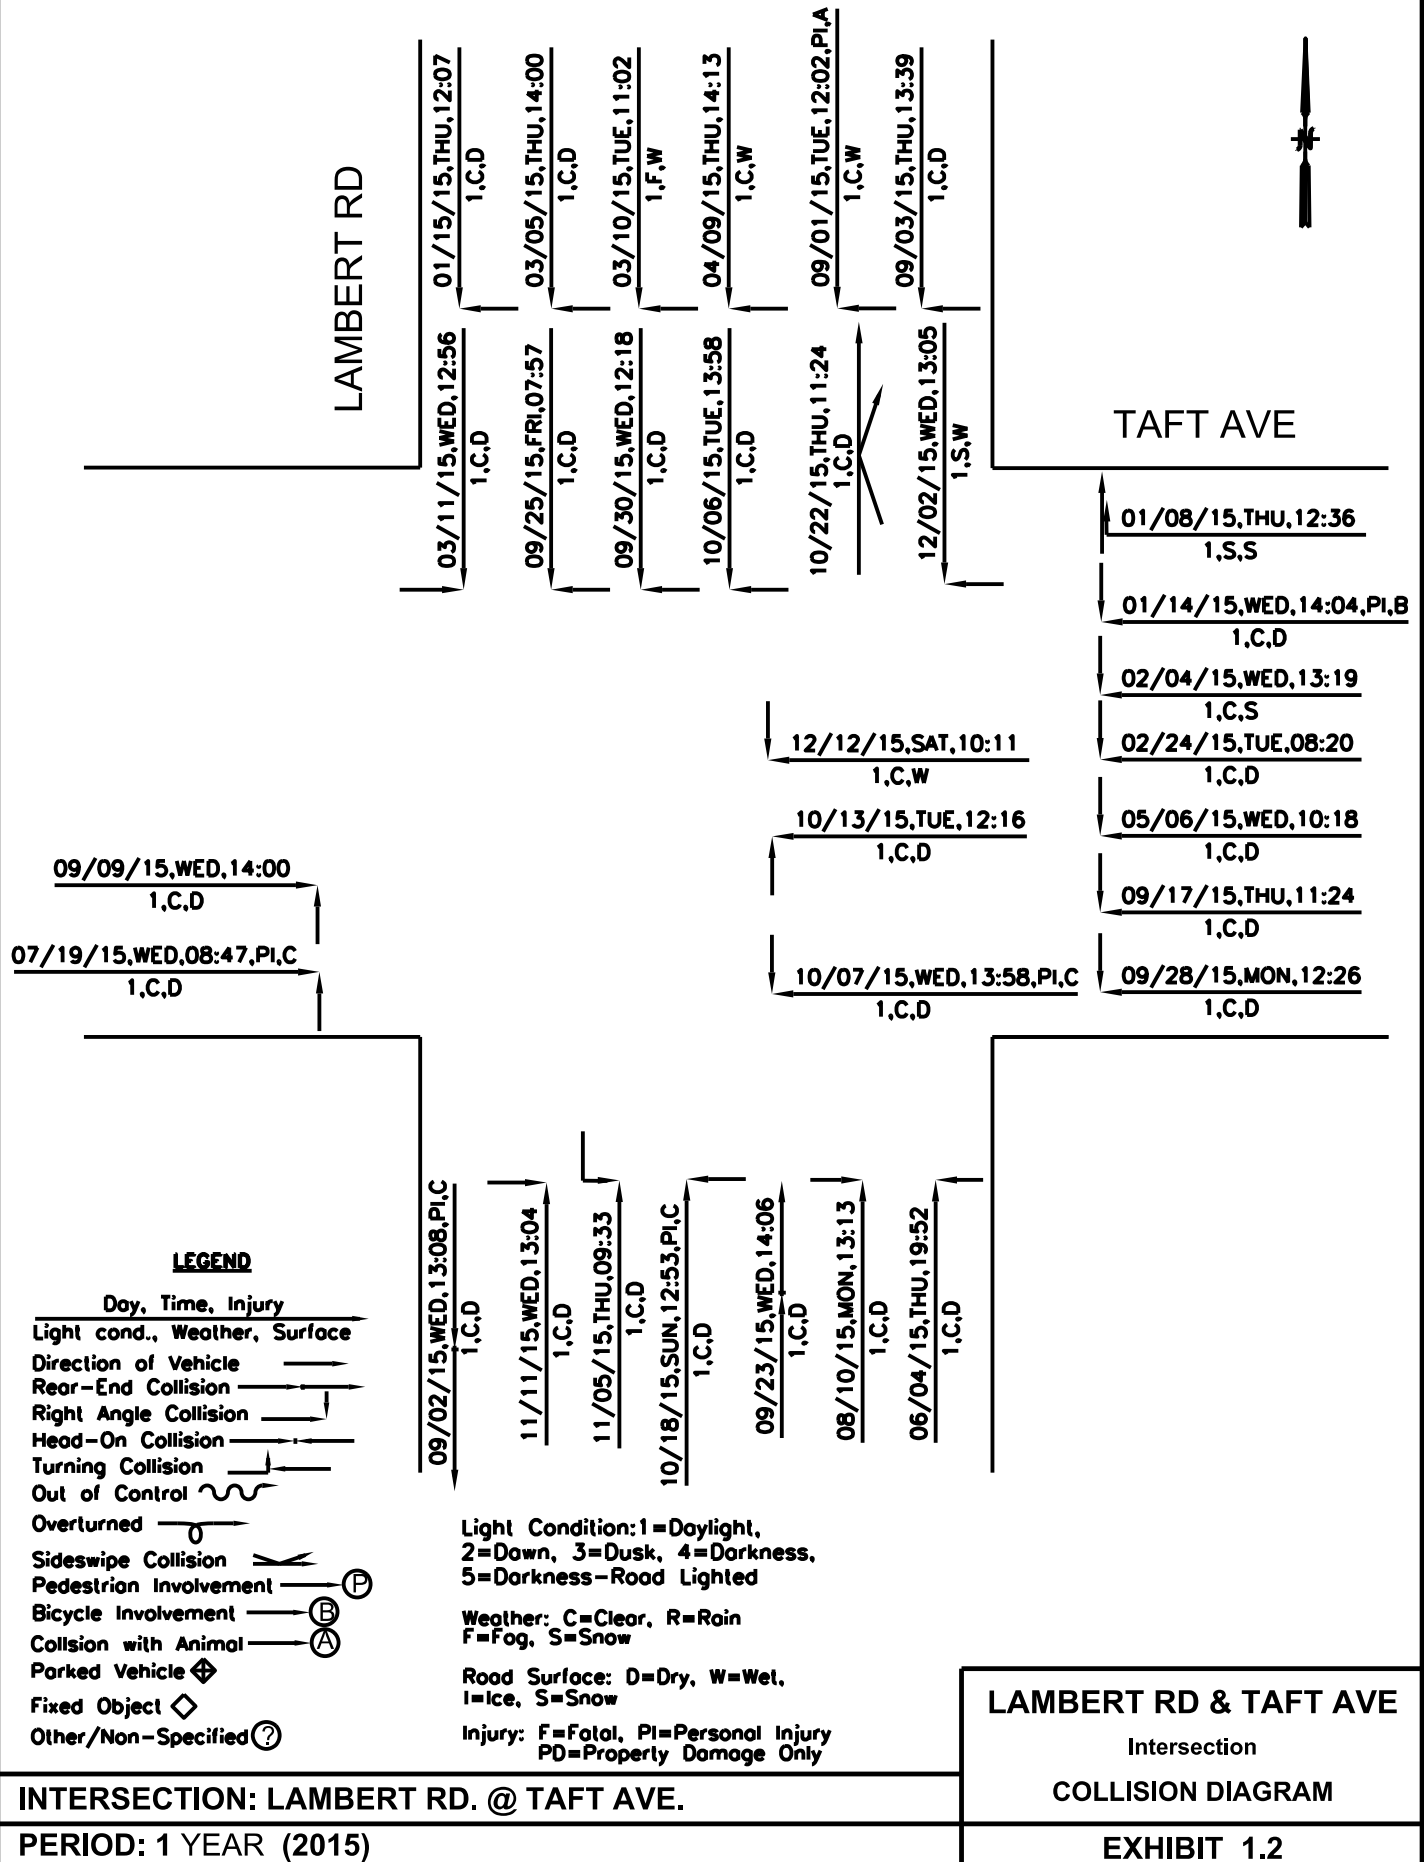
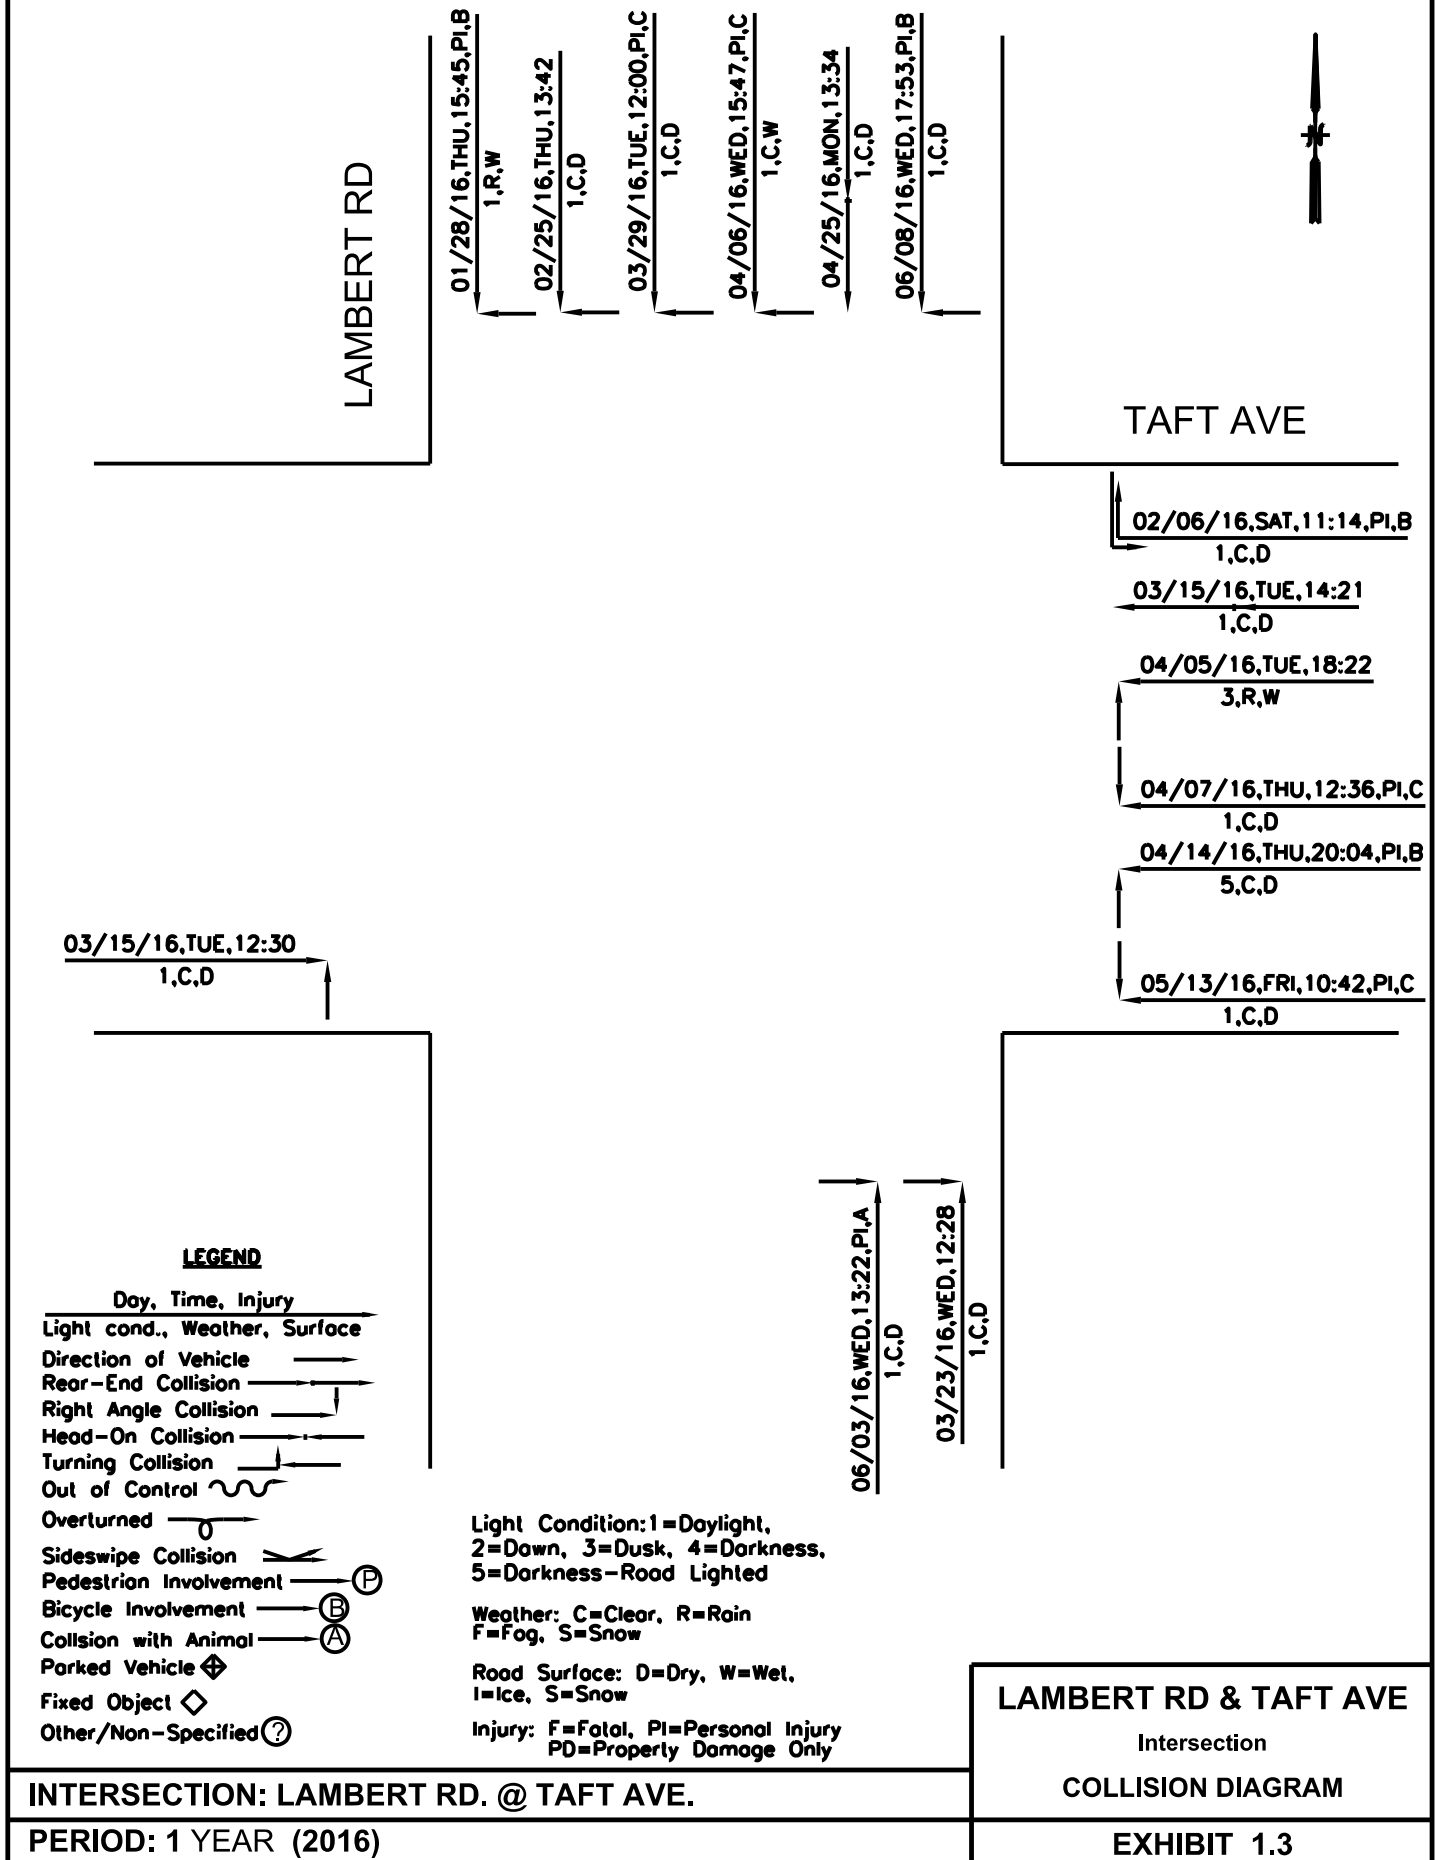
## COLLISION DIAGRAM

The predominant crash type is angle crash, making up 75.9% of the observed crashes. The second highest crash type is turning crash, with 14.5% of the crashes. The majority of these crashes occur between a southbound through vehicle and a westbound through vehicle. The most common theme in the driver statements was that the westbound vehicle could not see southbound traffic due to the queued vehicles in the northbound left-turn lane at IL Route 38 & Lambert Road. Drivers would state that they thought there was no southbound vehicle and proceeded straight through the intersection, colliding with a southbound vehicle. The second most common crash direction was eastbound through vehicles with northbound through vehicle. Similarly, eastbound drivers would state that they could not

see northbound traffic in the through lane due to queued vehicles in the northbound left-turn lane. Crash diagrams are attached to this memo as Exhibit 1.

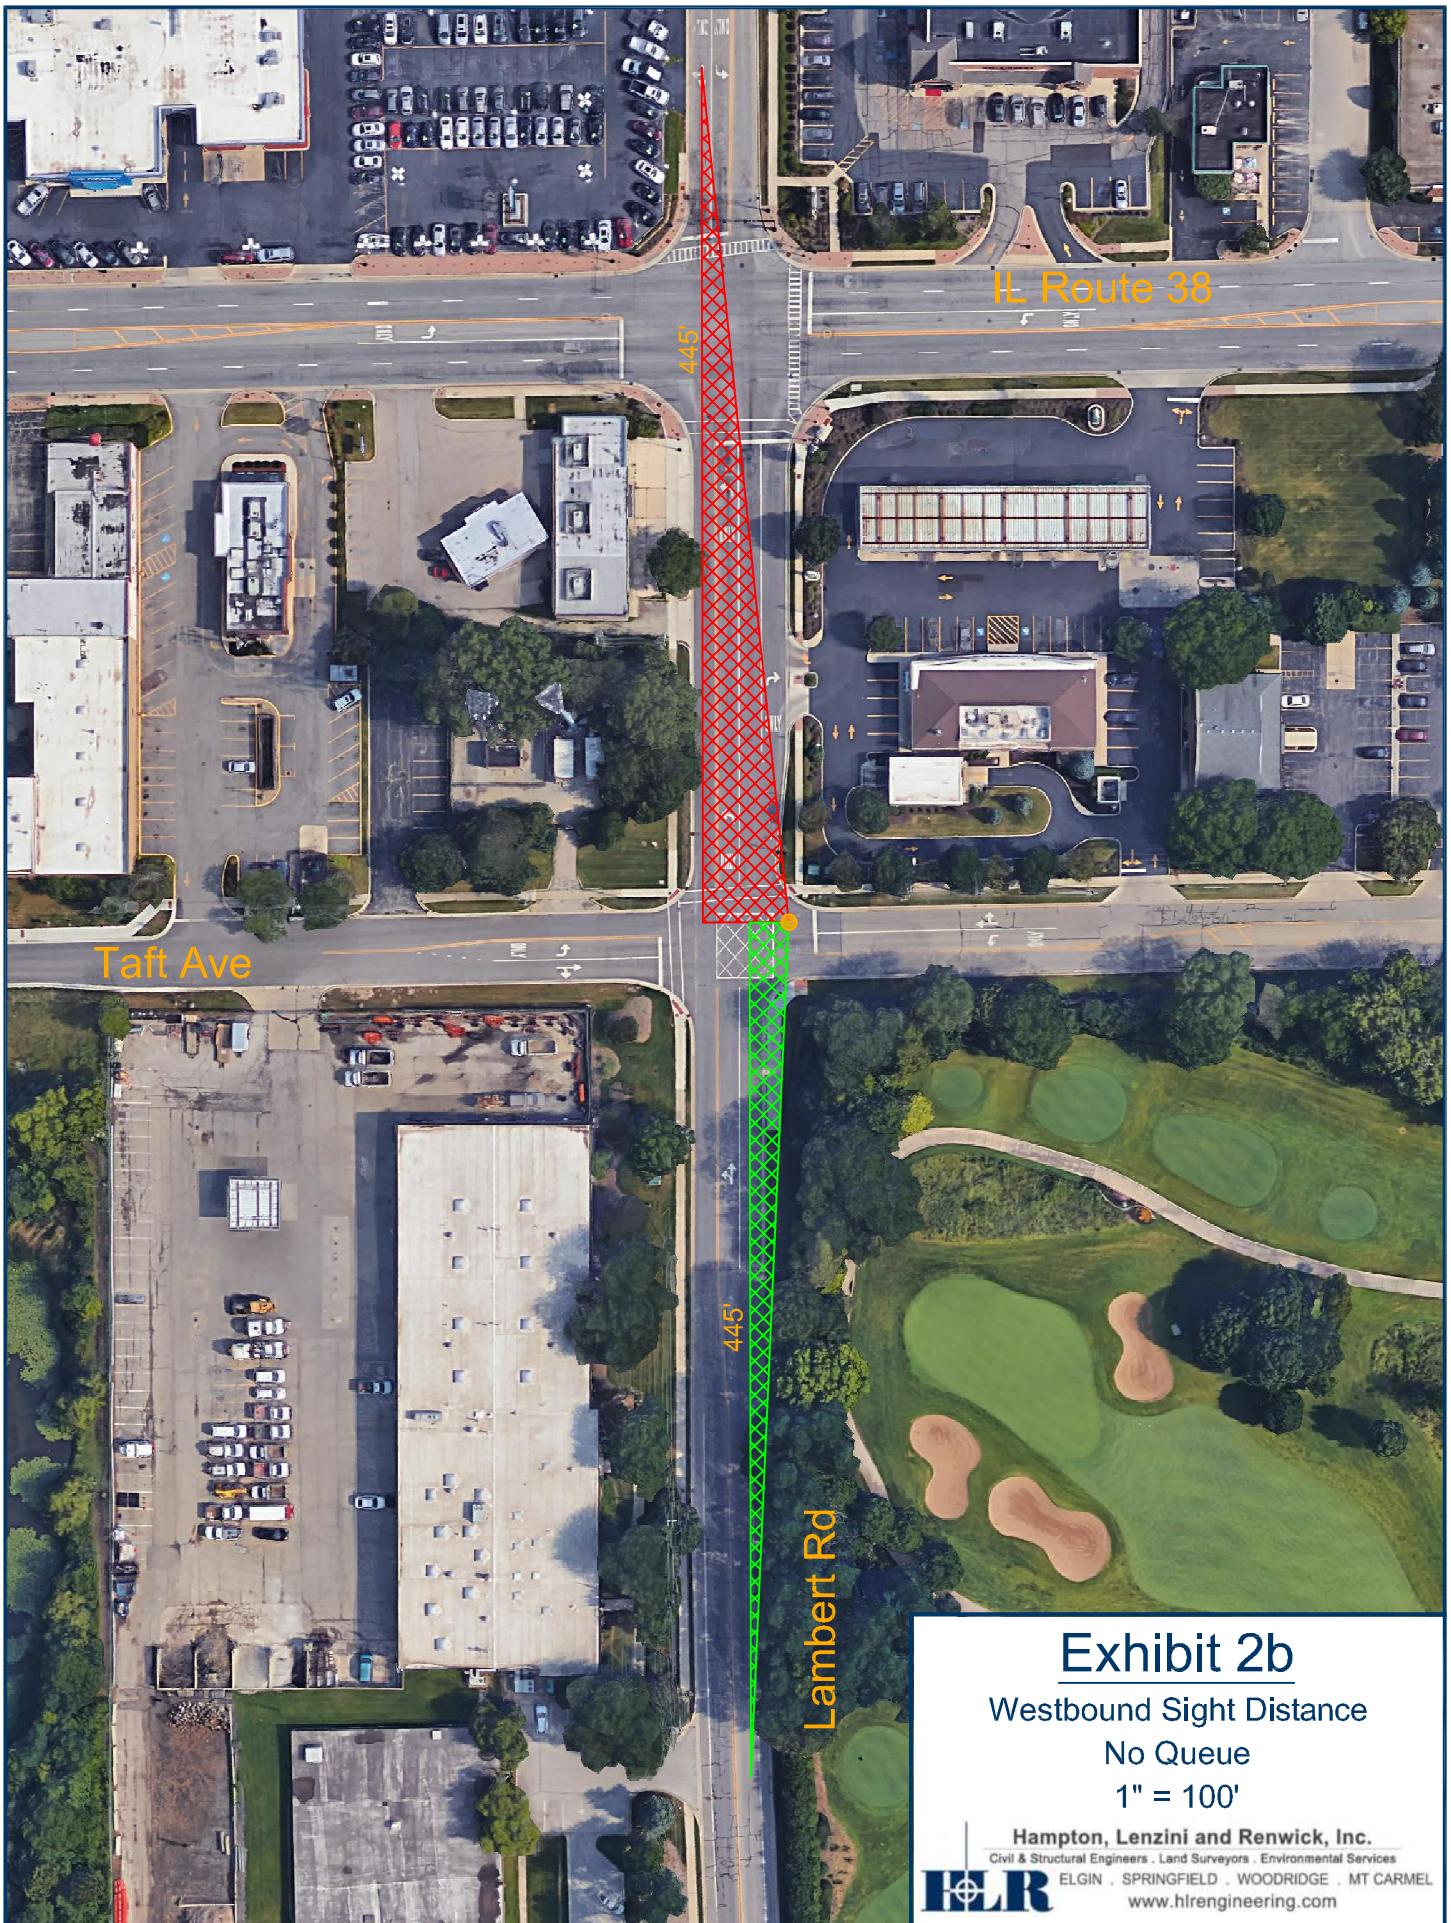
What was quickly evident was that vehicles queued in the northbound left-turn lane at IL Route 38 & Lambert Road can block the sight distance from westbound Taft Avenue looking north. It only takes three to four cars to be queued to significantly block sight distance. The majority of the cycles during the observation period had three to five vehicles queued in this lane. With three passenger cars queued, the sight distance to the north from the westbound approach is approximately 200 feet. The *Illinois Department of Transportation Bureau of Local Roads and Street Manual* requires 445 feet of sight distance for the existing conditions. Exhibit 2 attached to this memo shows the sight distance triangles for this intersection with no vehicles queued. With no cars queued adequate sight distance is available to the north and south from both Taft Avenue approaches. Exhibit 3 shows how the sight distance decreases significantly with a typical three car queue.
