Agenda  
Village of Glen Ellyn  
Special Village Board Workshop  
Monday, August 26, 2024  
6:00 PM  
Glen Ellyn Civic Center, Room 301

## **Discussion of the Acceptance of the Public Improvements for the Main Street Garage**

At the request of the Village of Glen Ellyn, Walker Consultants performed a Visual Review of the 400 Apex Parking Facility in Glen Ellyn, Illinois. The objectives of this Condition Assessment were to perform a visual review of the parking facility's readily observable structural and waterproofing systems to identify current distress and/or deterioration.

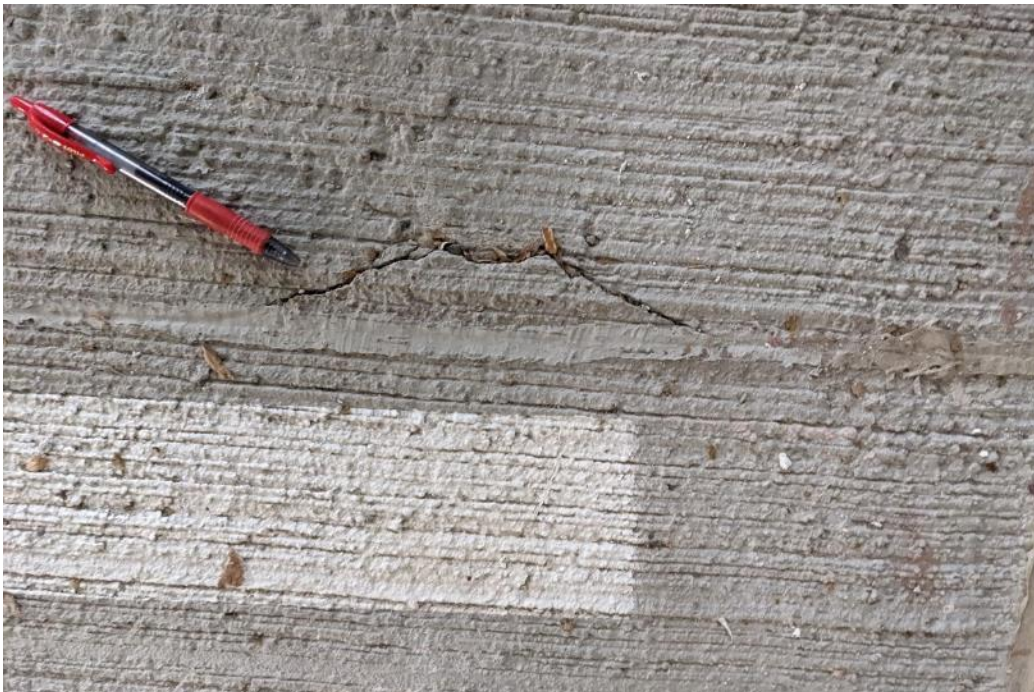
1. A few concrete cracks and delaminations were present in the floors at isolated locations (Photos 48 & 49).
2. We noted that the 2<sup>nd</sup> level topping slab did not have control joints at each hollow core slab joint, as is frequently used in parking structures, but incorporated a nominal 15'x15' control joint pattern.
3. Floor cracks in the concrete topping were common throughout the 2<sup>nd</sup> level floor and may allow water penetration (Photos 50 to 56). The cracks varied in size from hairline to over ¼" at one location. The

Photo 48. Isolated concrete delamination in the 2<sup>nd</sup> level topping slab.

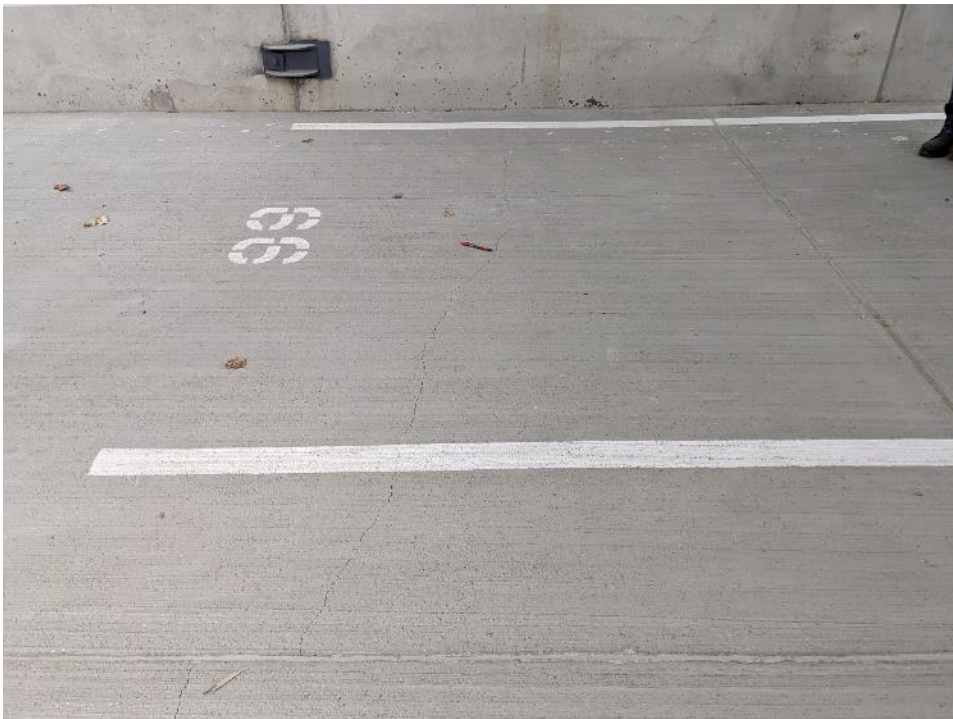
Photo 54. Typical crack in 2<sup>nd</sup> level floor topping slab perpendicular to the hollow core planks.
