Agenda  
Village of Glen Ellyn  
Special Village Board Workshop  
Monday, September 9, 2024  
6:00 PM  
Glen Ellyn Civic Center, Room 301

## **Discussion of the Acceptance of the Public Improvements for the Main Street Garage**

At the request of the Village of Glen Ellyn, Walker Consultants performed a Visual Review of the 400 Apex Parking Facility in Glen Ellyn, Illinois. The objectives of this Condition Assessment were to perform a visual review of the parking facility's readily observable structural and waterproofing systems to identify current distress and/or deterioration.

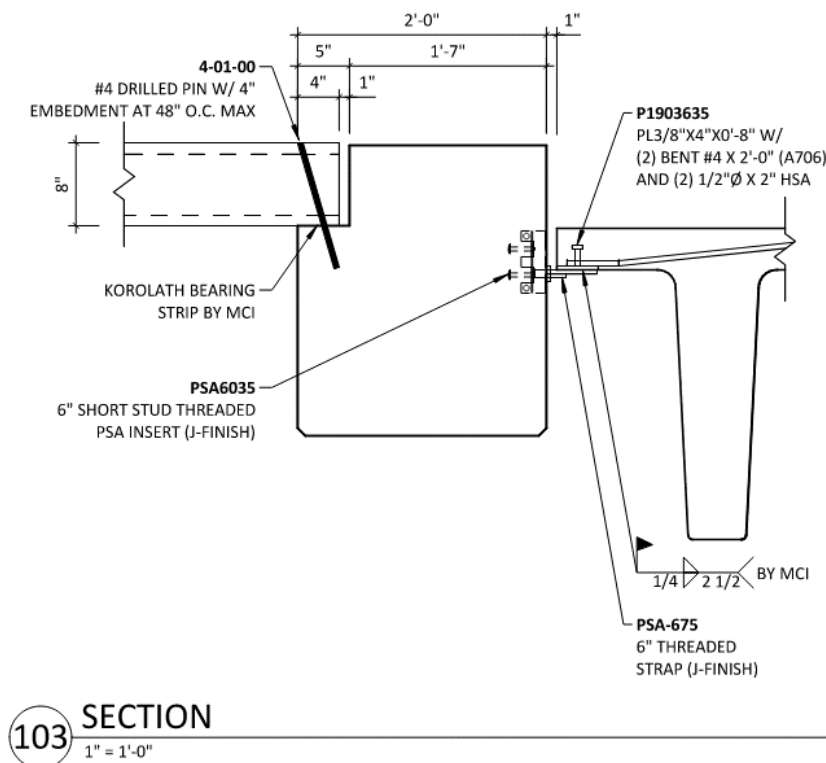
#### Connection Type 103 from Mid-States Precast Drawing SP304

- a. Spall locations 5, 6, 7, and 8 were specified to have Connection Type 103. This detail specified a “#4 DRILLED PIN W/ 4” EMBEDMENT AT 48” O.C. MAX” as seen below. The specified pins appear consistent with the steel dowels we observed at the center of each of these spalls. The connection detail also specifies a “Korolath Bearing Strip,” but we were unable to observe a bearing pad along the joint or within the spalled cavity from the ground. The opposite end was specified to have Connection Type 80 or 95 which is similar to Connection Type 87 below.

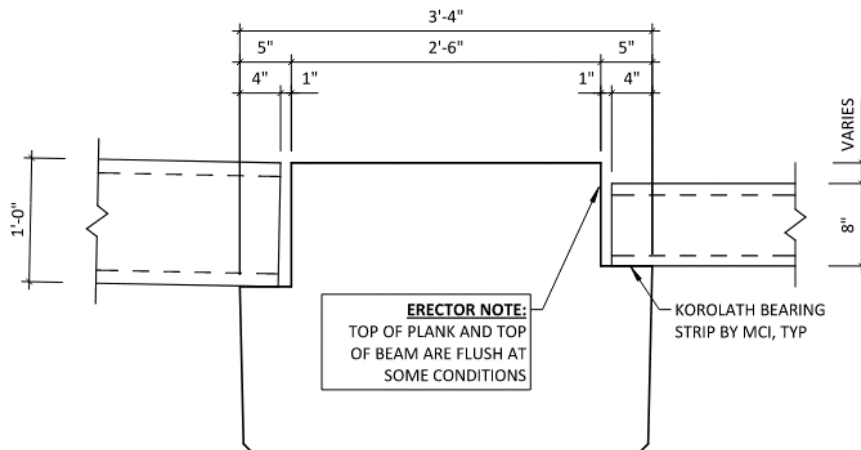
### Connection Type 87 from Mid-States Precast Drawing SP303

- b. Spall locations 1, 2, and 3 were specified to have Connection Type 87. We noted that this connection detail, shown below, does not include a steel dowel that was observed in the field. The steel dowels observed appear similar to the pins shown in Connection Type 103 above. The

connection detail also specifies a “Korolath Bearing Strip,” but we were unable to observe a bearing pad along the joint or within the spalled cavity from the ground. We noted the opposite end of the plank was specified to have Connection Type 110, which includes a welded fixed bearing.

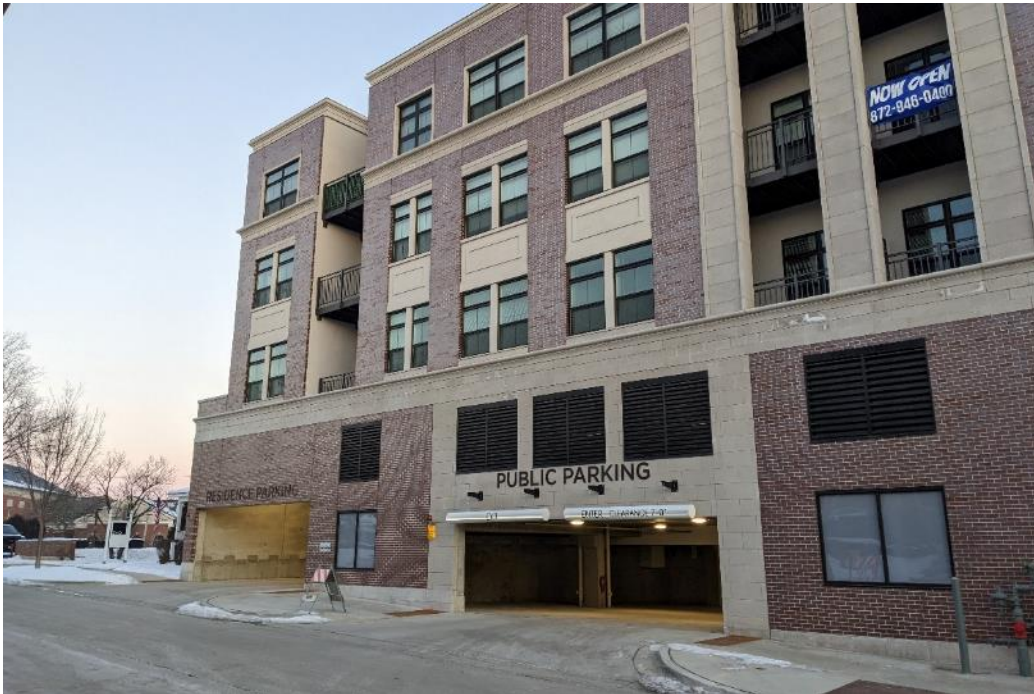
Photo 1. Overall view of the south entrance for public and resident parking.

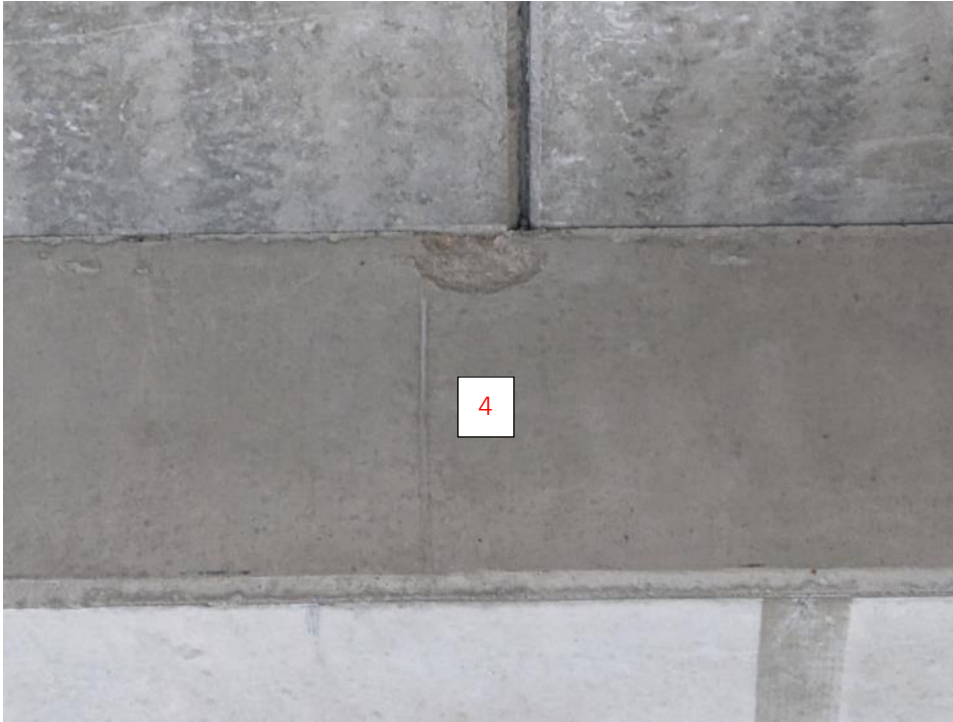
Photo 9. Spall 4 along Grid 7.8 from Photo 8. Note, presence of a bearing pad is not obvious from ground.

1. Because the cause and extent of the overhead concrete spalling at the beams is currently unknown, and because some of the observed as-built connections do not appear to be consistent with the information given in the provided “Issued for Construction” precast drawings, we recommend that additional investigation by a licensed professional be performed to determine the cause and extent of spalling and related distress at the beams. We recommend the investigation, at a minimum, should include the following:

2. Because concrete spalling along the beams has occurred at different times and the cause and extent of the issues is not currently known, we recommend that protective covering for the face of all inverted tee beams without welded connections be designed and installed to contain future concrete deterioration from falling to the ground. This protective covering shall be installed immediately and maintained until additional investigation and/or repairs are completed.

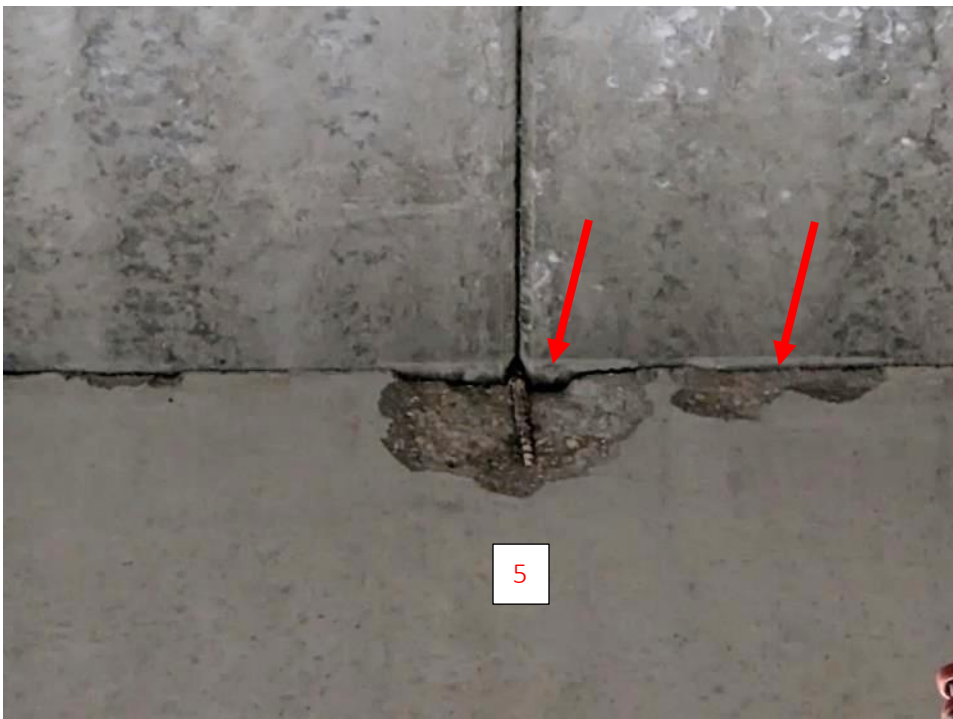
Photo 10. Spall 5 along Grid 7.8 from Photo 8. Note, presence of dowel at center of spall. Also note an adjacent small spall. Presence of a bearing pad is not obvious from ground.

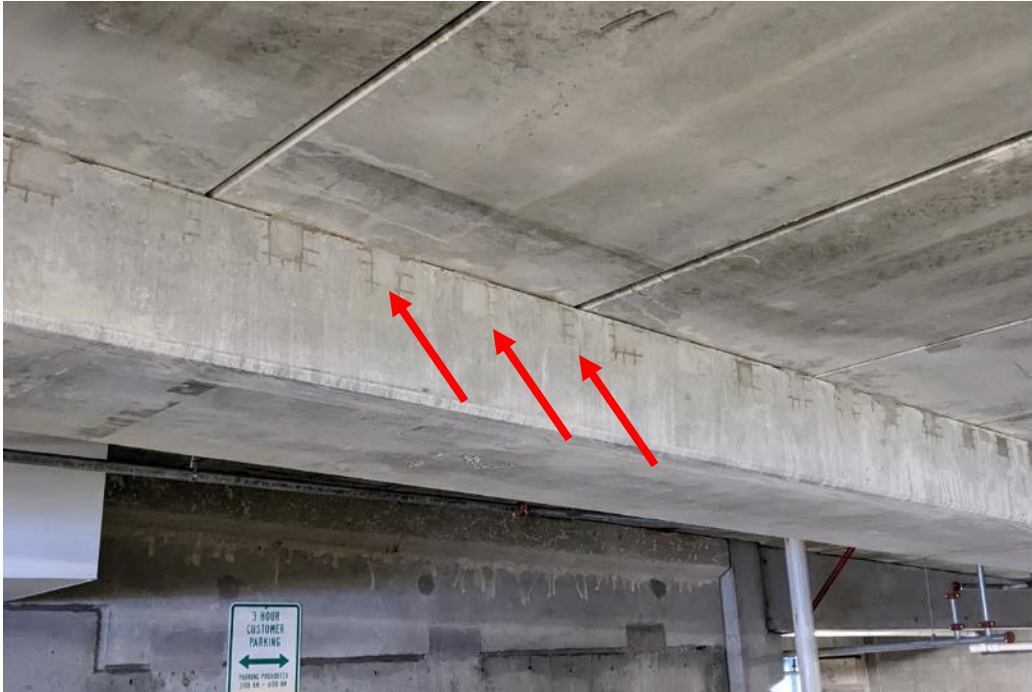
3. A series of small concrete repair patches were observed at two inverted tee beams along Grid 4 directly beneath the hollow core bearing (Photo 15). The patches were estimated to be 5"x5" and 1 foot on center. The reason for the patches is unknown, but locations are similar to inverted tee beams experiencing concrete spalling and therefore should be reviewed.

Photo 15. Approximately 22 patches were seen on two inverted tee beams along Grid Line 4.

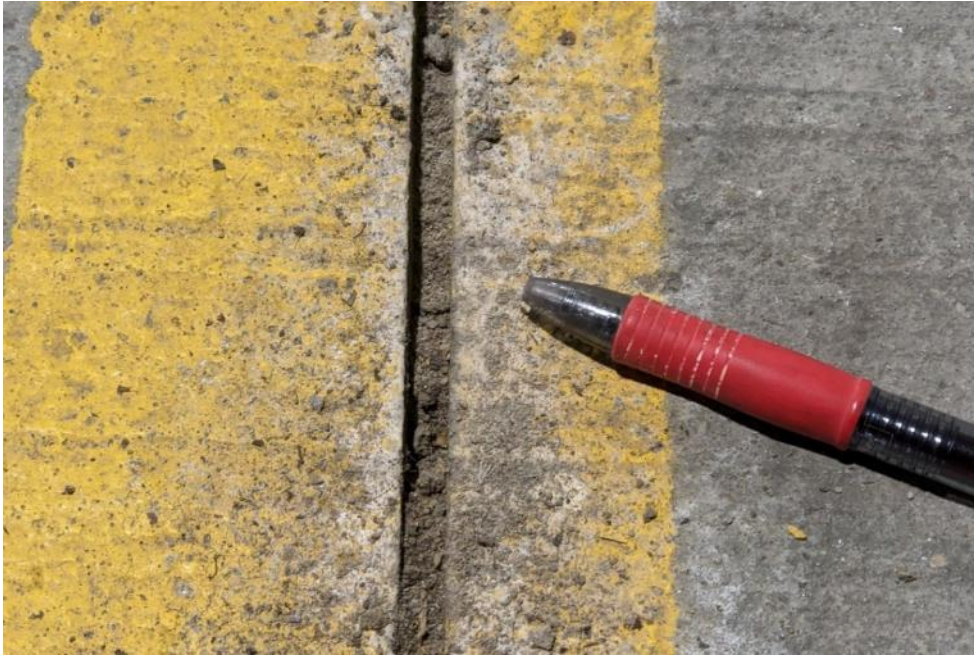
1. Sealant was present in some of the slab-on-ground floor control joints in the south end but was typically not present in areas of the main section and finger slab-on-ground, as would often be required in a parking structure. (Photos 16 - 20).
2. Small concrete distress spalls were observed along a couple of slab-on-ground control joints in the finger area (Photos 19 and 20).
3. The slab-on-ground exhibited frequent random, narrow unsealed cracks (Photos 20 and 21).
4. At some finger column locations, the slab-on-ground included diamond shaped isolation control joints around the columns, while at locations along the south edge of the finger the control joints were not

Photo 17. Typical slab-on-ground with missing control joint sealant.

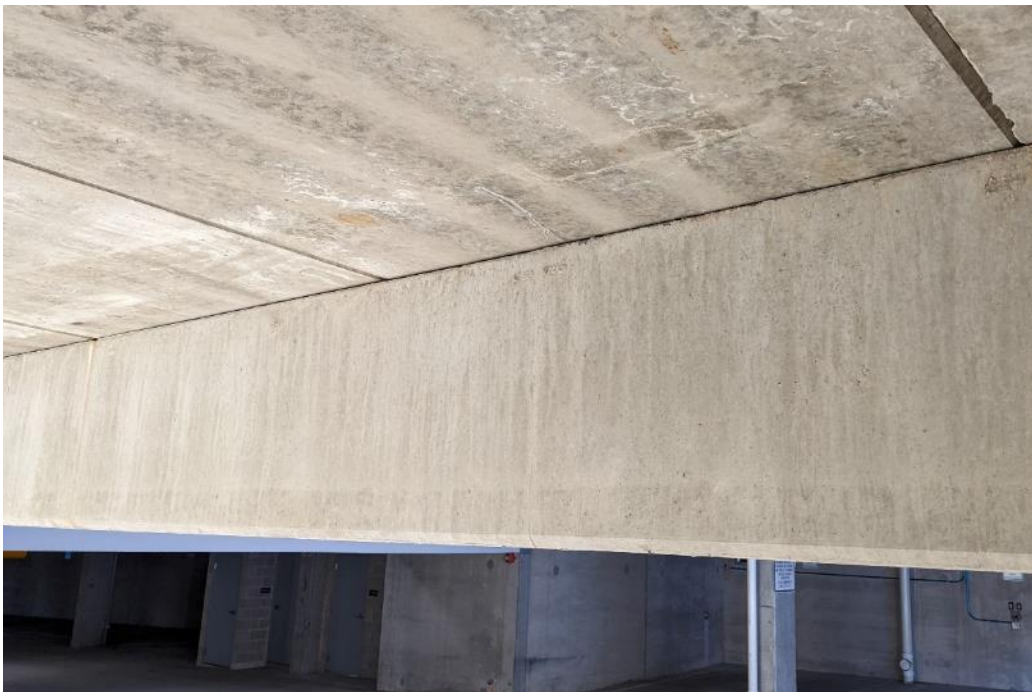
10. It was generally noted that there was a minimal gap observed between the inverted tee beam and hollow core plank. A bearing pad was typically not observable from the ground and may indicate that bearing pads were omitted (Photo 44).

Photo 44. Typical minimal gap separating the hollow core planks from the beams.

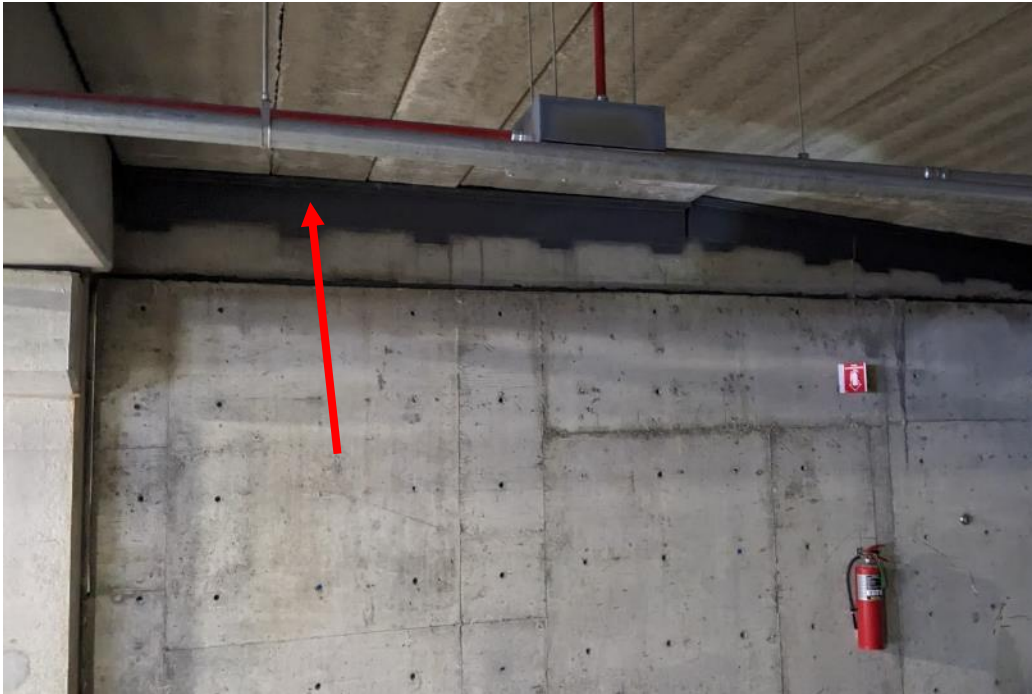
11. Beneath the 2<sup>nd</sup> level entrance ramp, steel angles are used to provide bearing support for the hollow core planks. At one location the plank appears to have less bearing area than is commonly required for a hollow core plank bearing on a steel angle and should be reviewed. (Photos 45 and 46).

Photo 45. A steel angle supporting the 2<sup>nd</sup> level ramp hollow core plank.

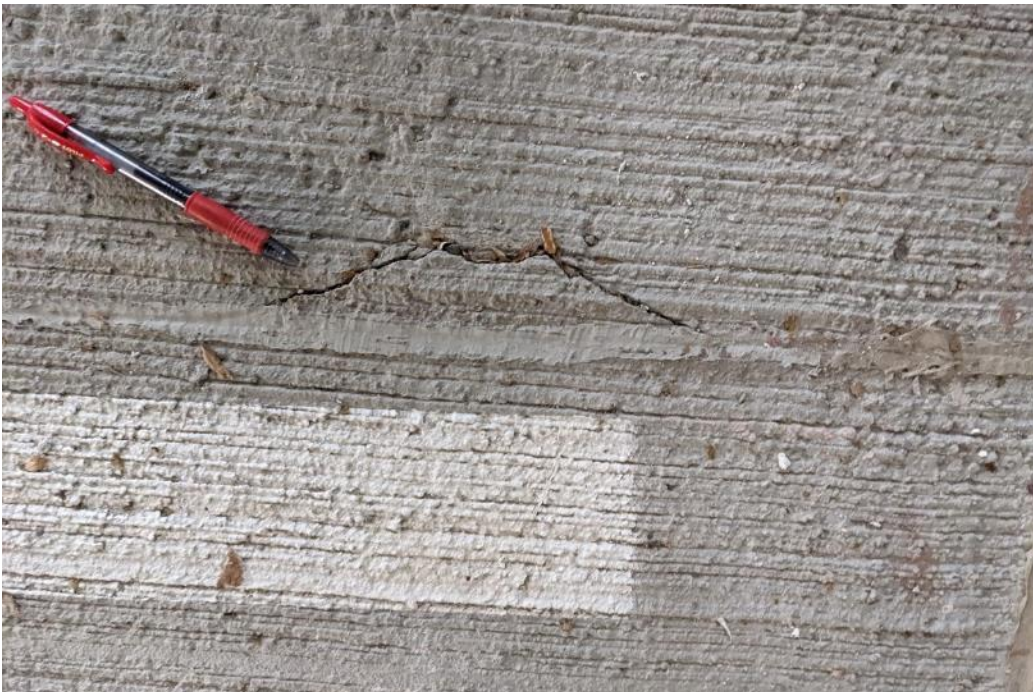
Photo 48. Isolated concrete delamination in the 2<sup>nd</sup> level topping slab.

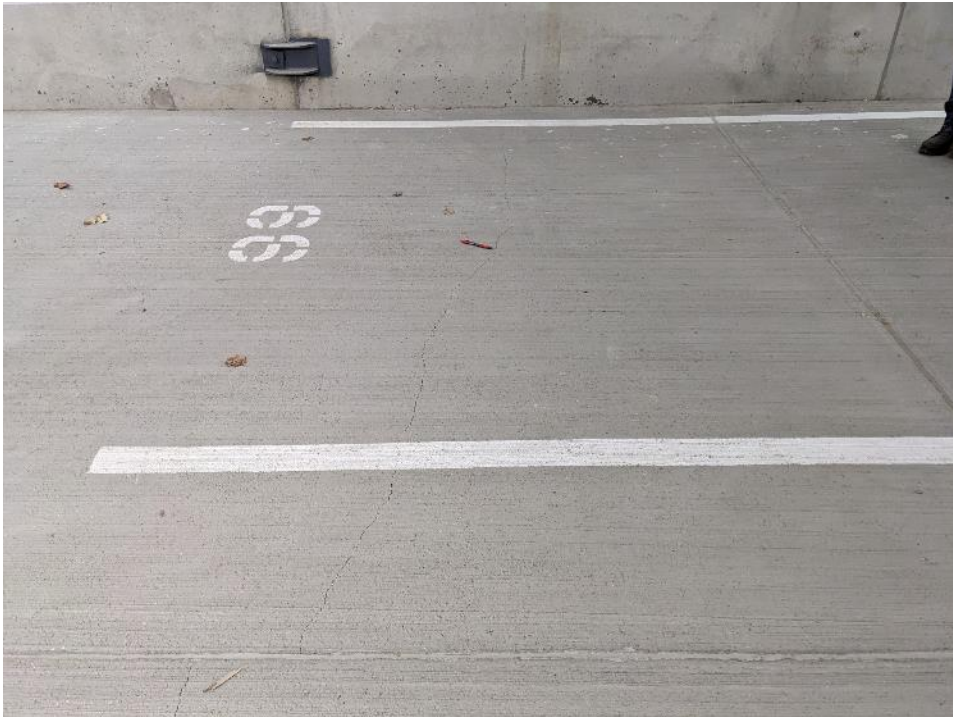
Photo 54. Typical crack in 2<sup>nd</sup> level floor topping slab perpendicular to the hollow core planks.

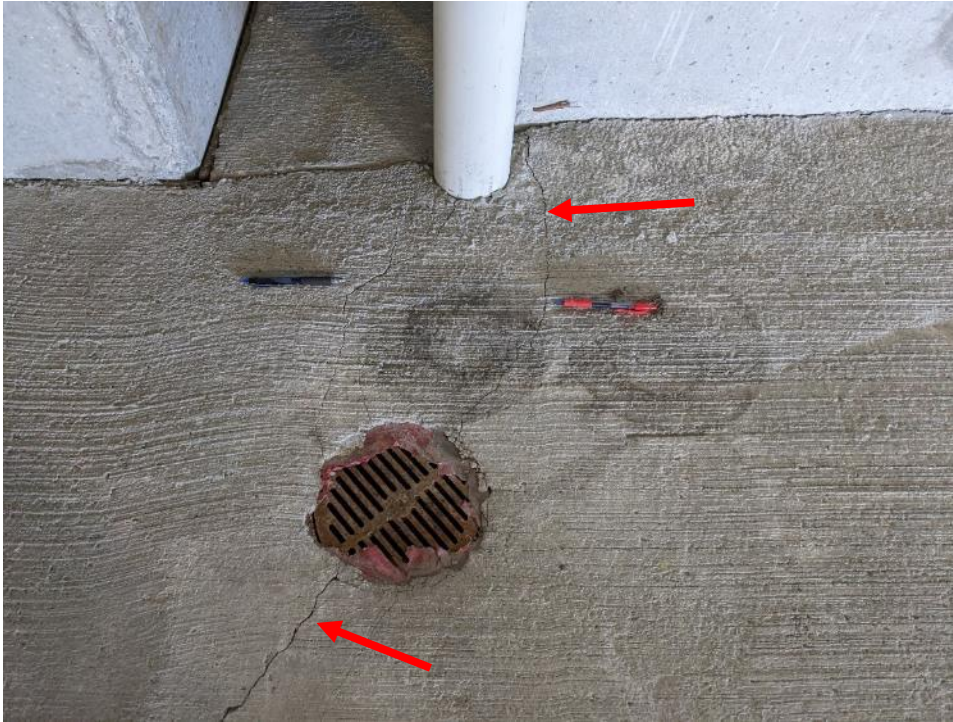
Photo 55. Floor cracks through drain penetrations in the 2<sup>nd</sup> level floor.

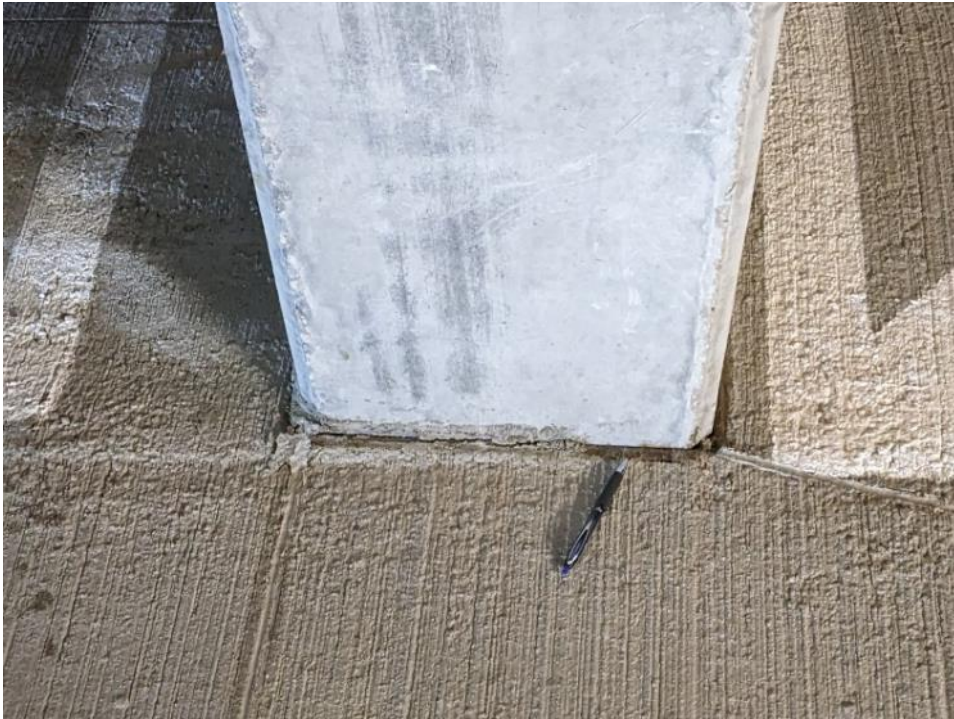
Photo 64. Cove sealant was typically missing at the column bases.

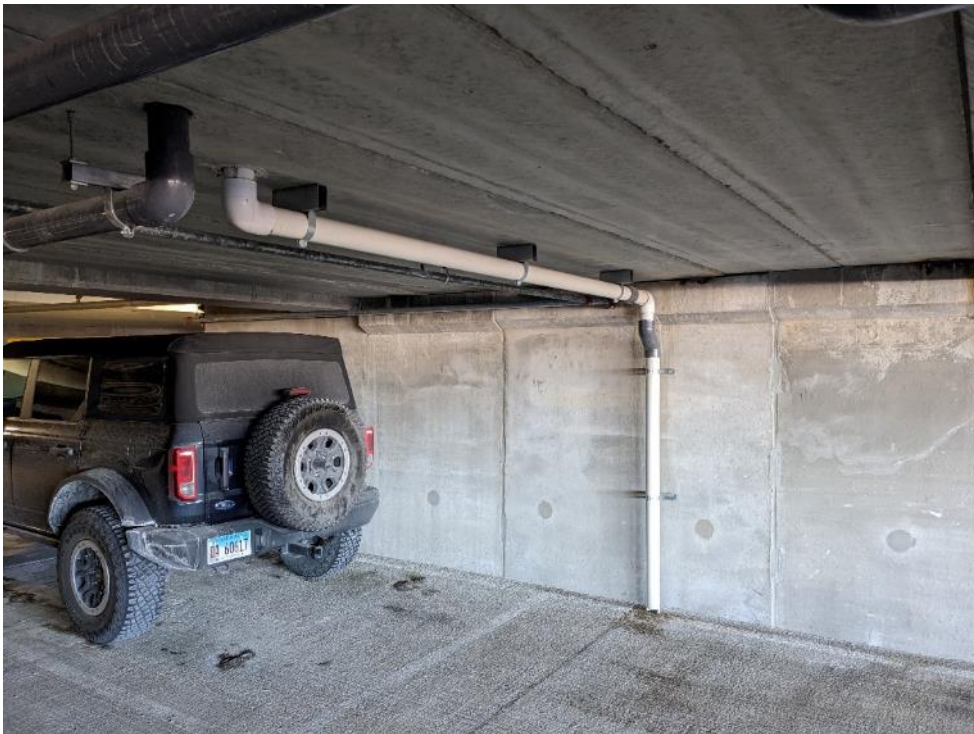
Photo 74. Plaza level drainpipe draining directly onto 2<sup>nd</sup> level floor.
